Site Map with Photo Locations	Former D&G Operating Company Evans Unit 05775 Lease Chambers County Winnie, Texas
March 2005	
Figure 8	<i>CORRIGAN CONSULTING, INC.</i>

**Photograph No. 1 – Former D & G Operating Company, Evans Unit Well #1 Site, Winnie, TX**  
View of fenced area with on-site structures. Facing South (MSH 04/14/04)

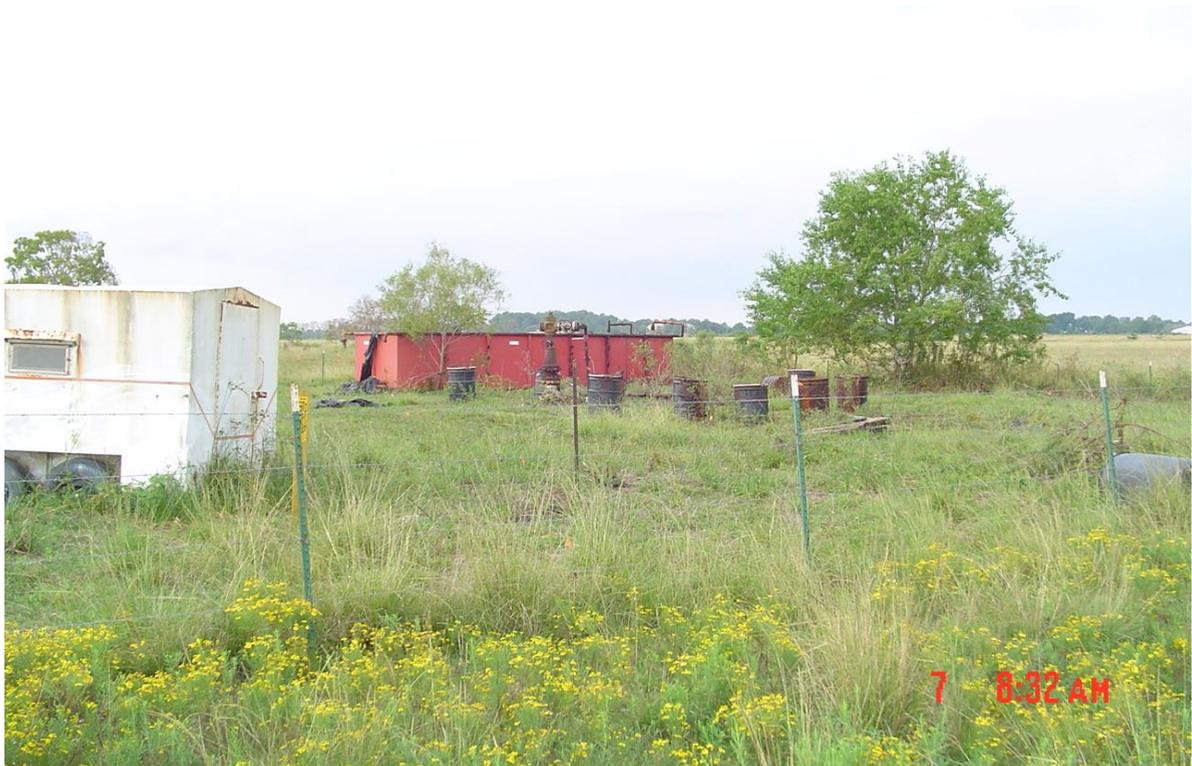
**Photograph No. 2 – Former D & G Operating Company, Evans Unit Well #1, Winnie, TX**  
View of fenced area with on-site structures. Facing Southwest (JW 10/07/04)

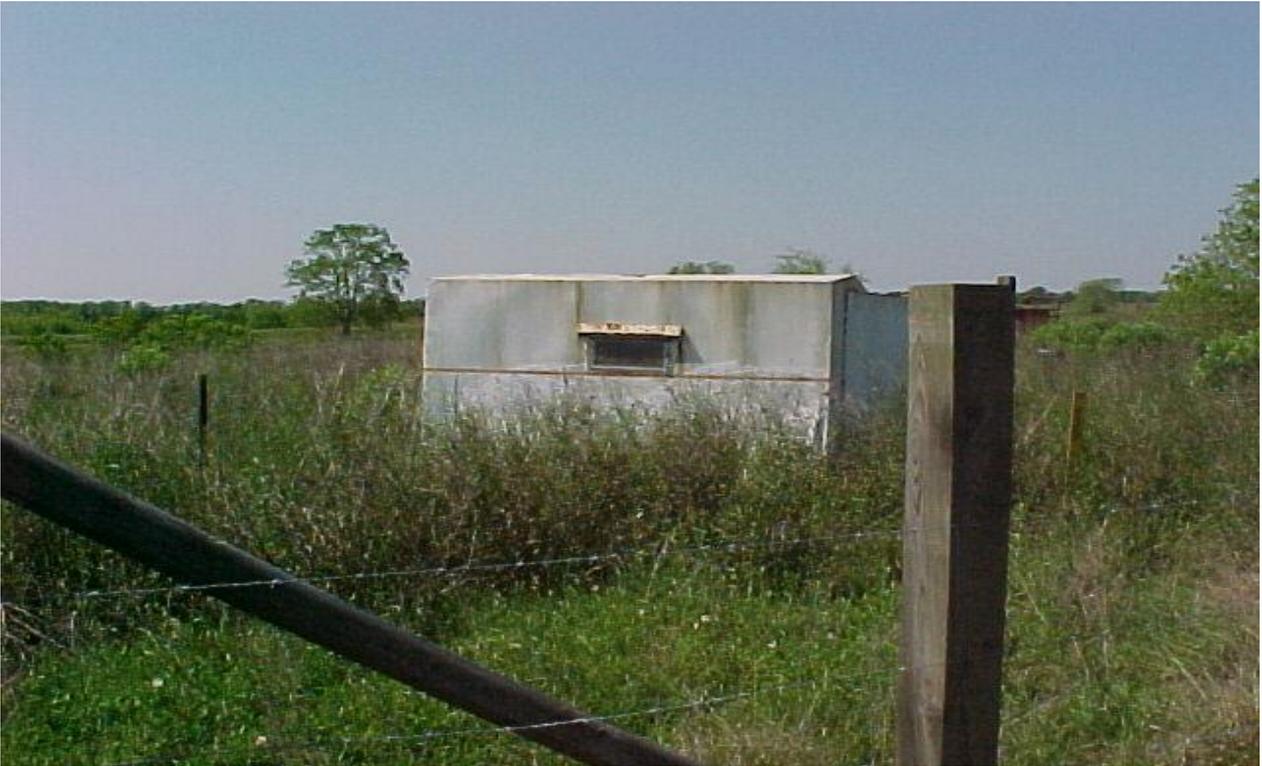
**Photograph No. 3 – Former D & G Operating Company, Evans Unit Well #1, Winnie, TX**  
View of tool trailer located within fenced area. Facing South (MSH 04/14/04)

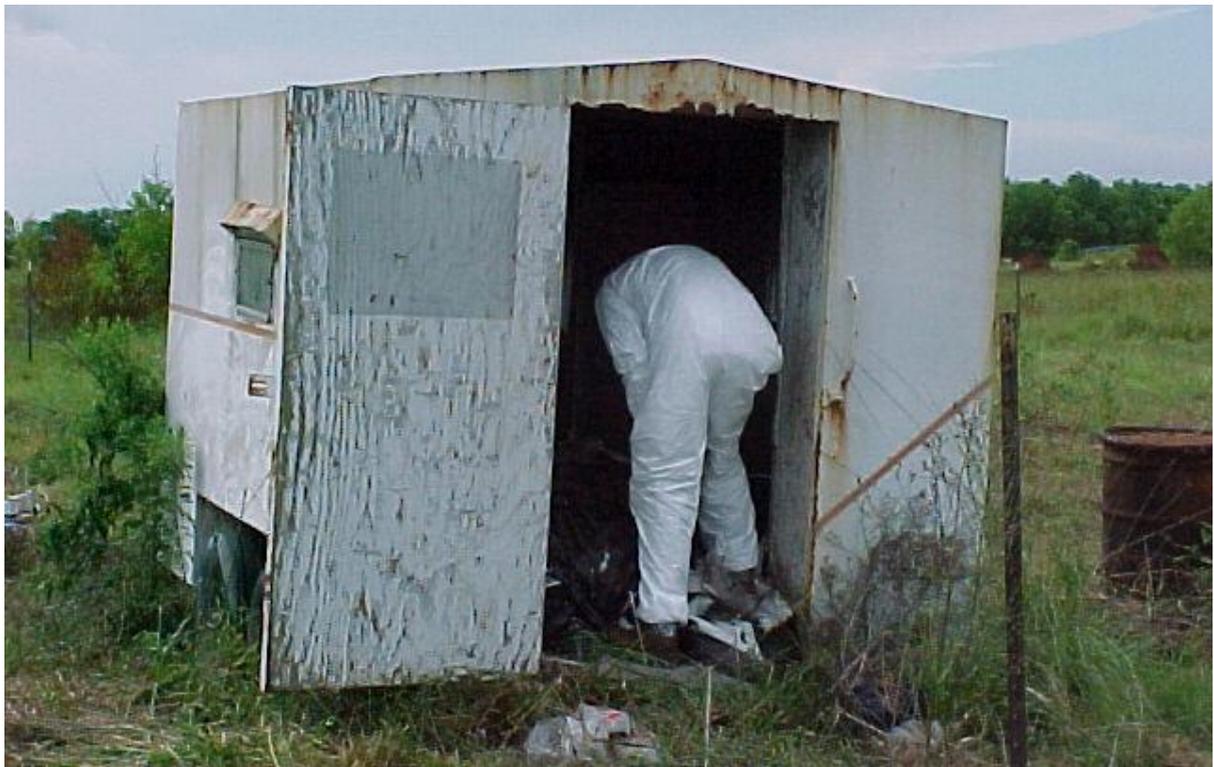
**Photograph No. 4 – Former D & G Operating Company, Evans Unit Well #1, Winnie, TX**  
View of an ARS technician collecting samples from inside tool house. Facing Southeast (JW 07/21/04)

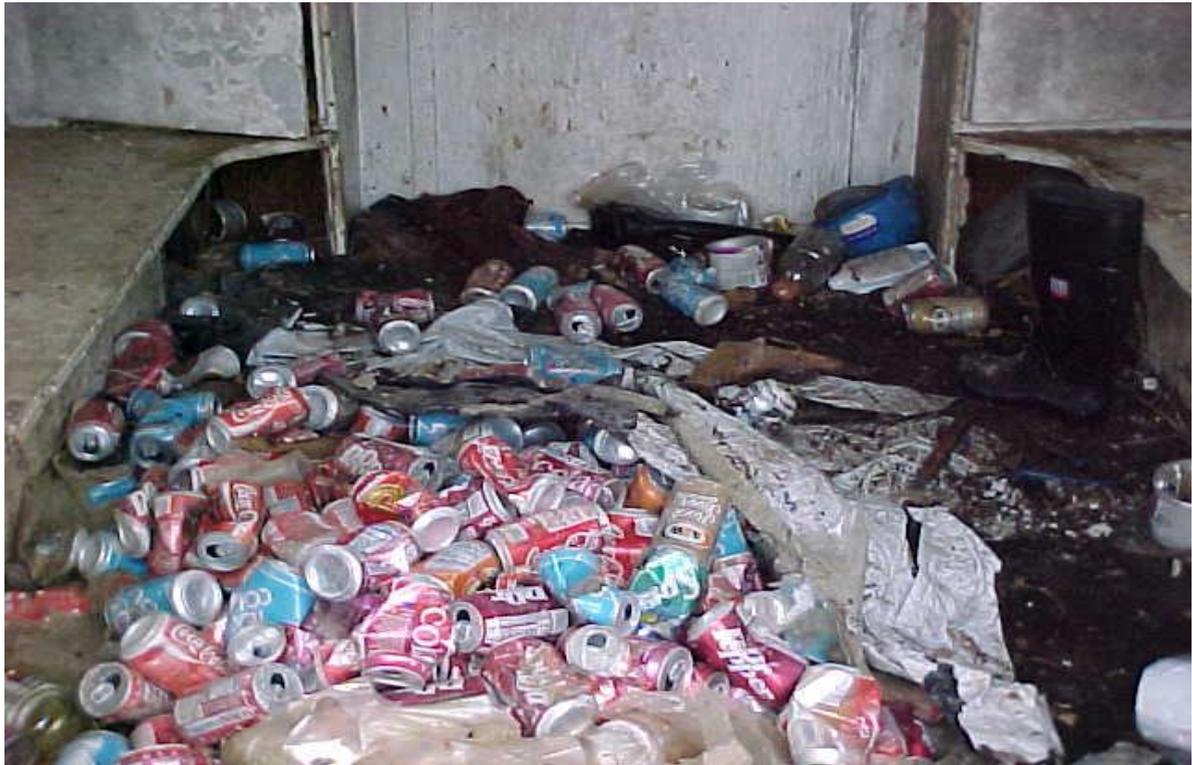
**Photograph No. 5 – Former D & G Operating Company, Evans Unit Well #1, Winnie, TX**  
View of trash inside tool house. (JW 07/21/04)

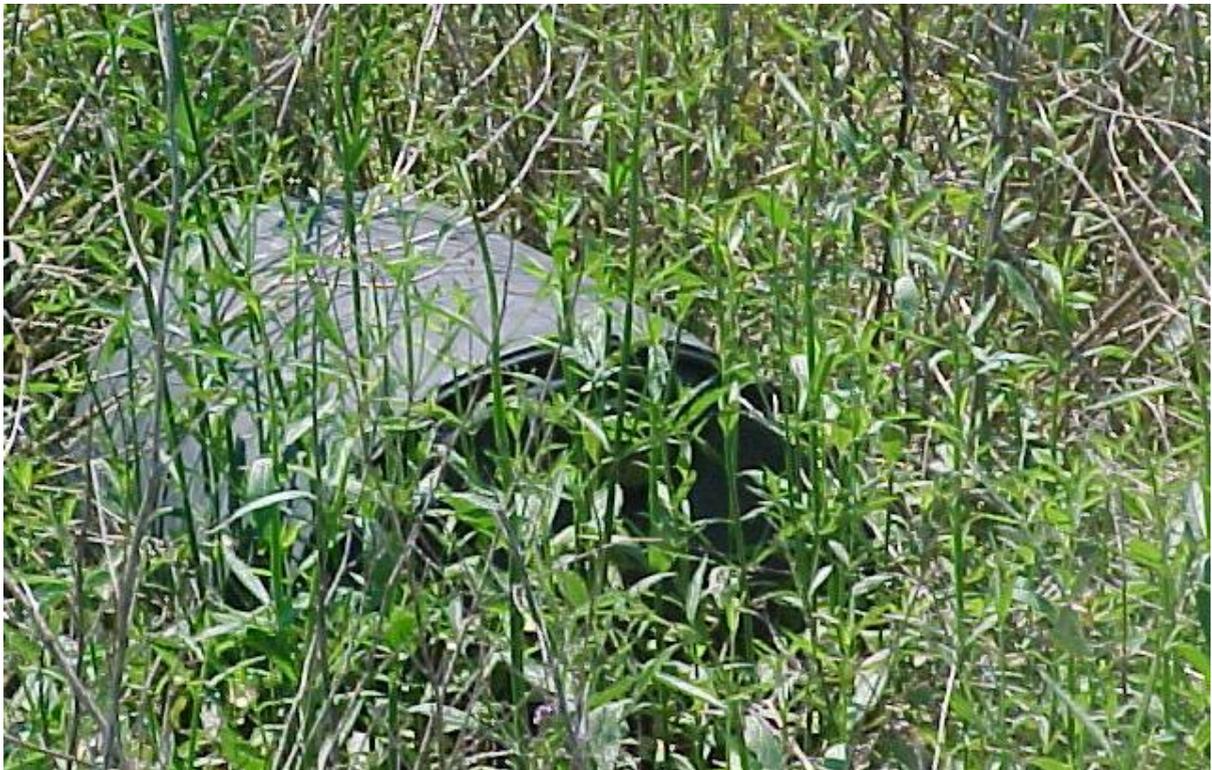
**Photograph No. 6 – Former D & G Operating Company, Evans Unit Well #1, Winnie, TX**  
View of plastic drum lying on its side, within fenced area. Contents unknown. Facing South (MSH 04/14/04)

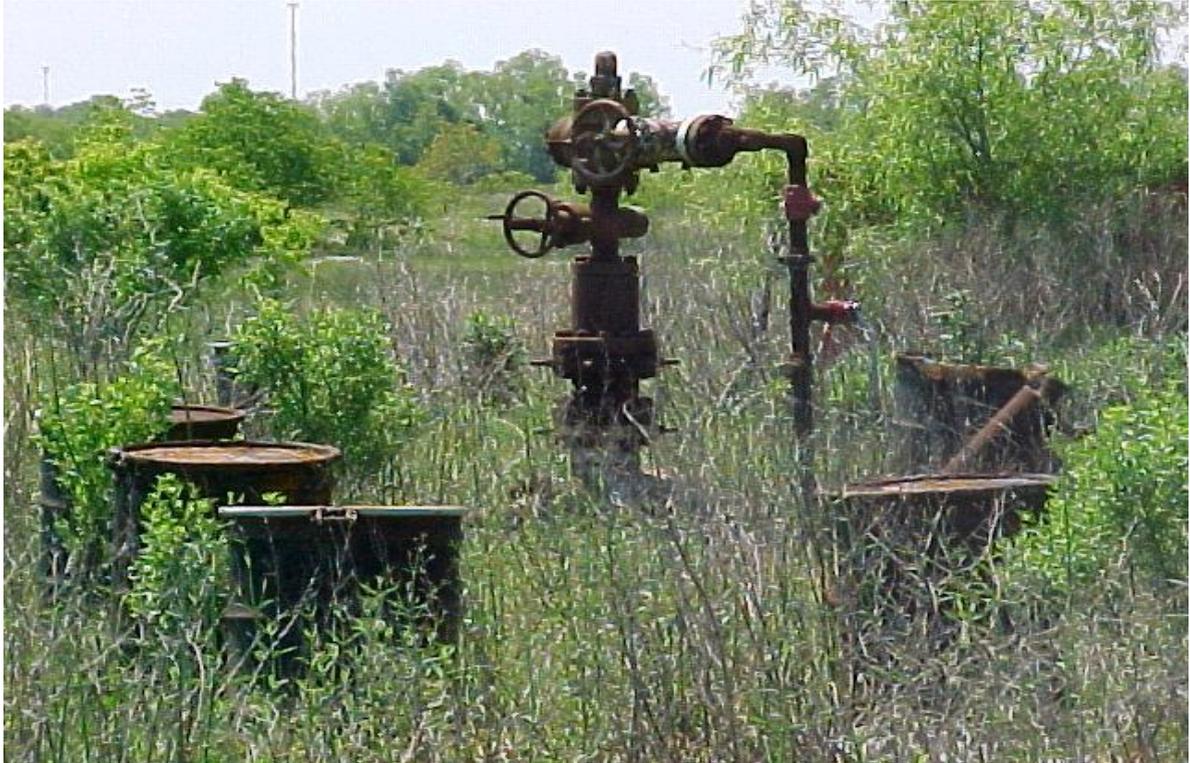
**Photograph No. 7 – Former D & G Operating Company, Evans Unit Well #1, Winnie, TX**  
View of the close-up of wellhead structure and 55-gallon drums within fenced area. Facing South (MSH 04/14/04)

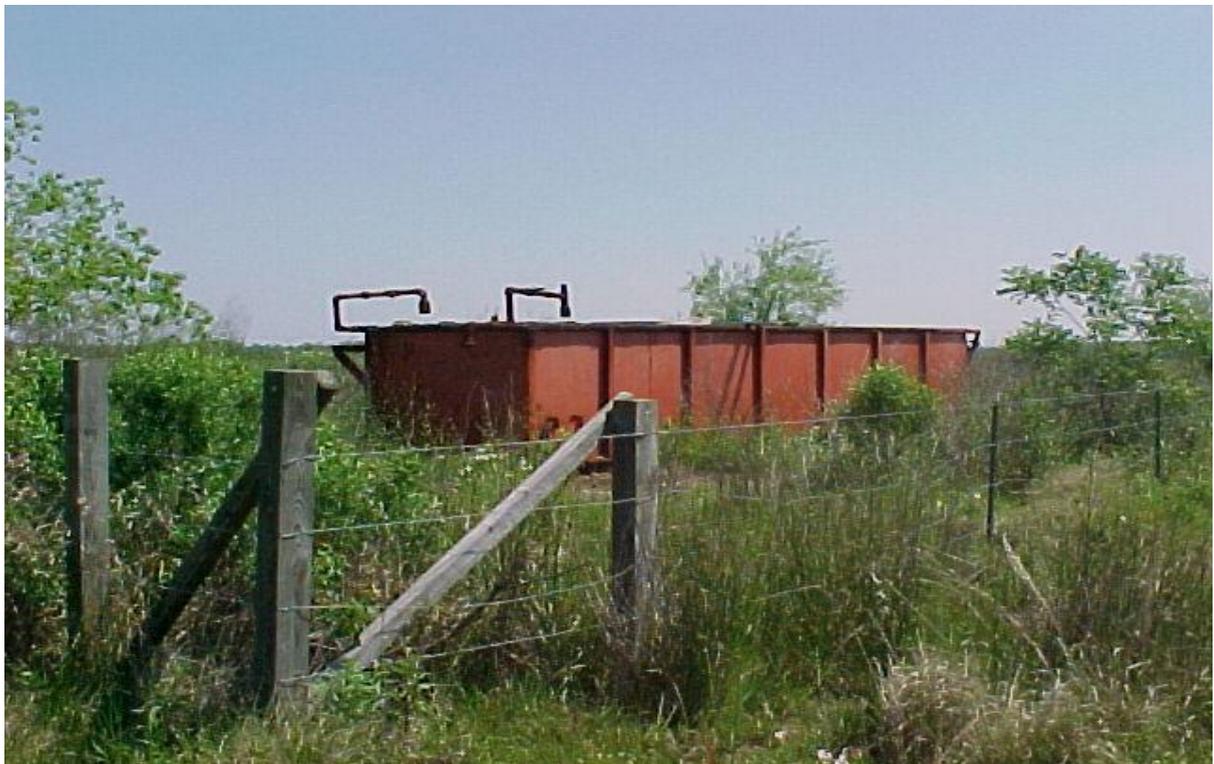
**Photograph No. 8 – Former D & G Operating Company, Evans Unit Well #1, Winnie, TX**  
View of the steel workover tank in southwest portion of fenced area. Facing Northeast (MSH 04/14/04)

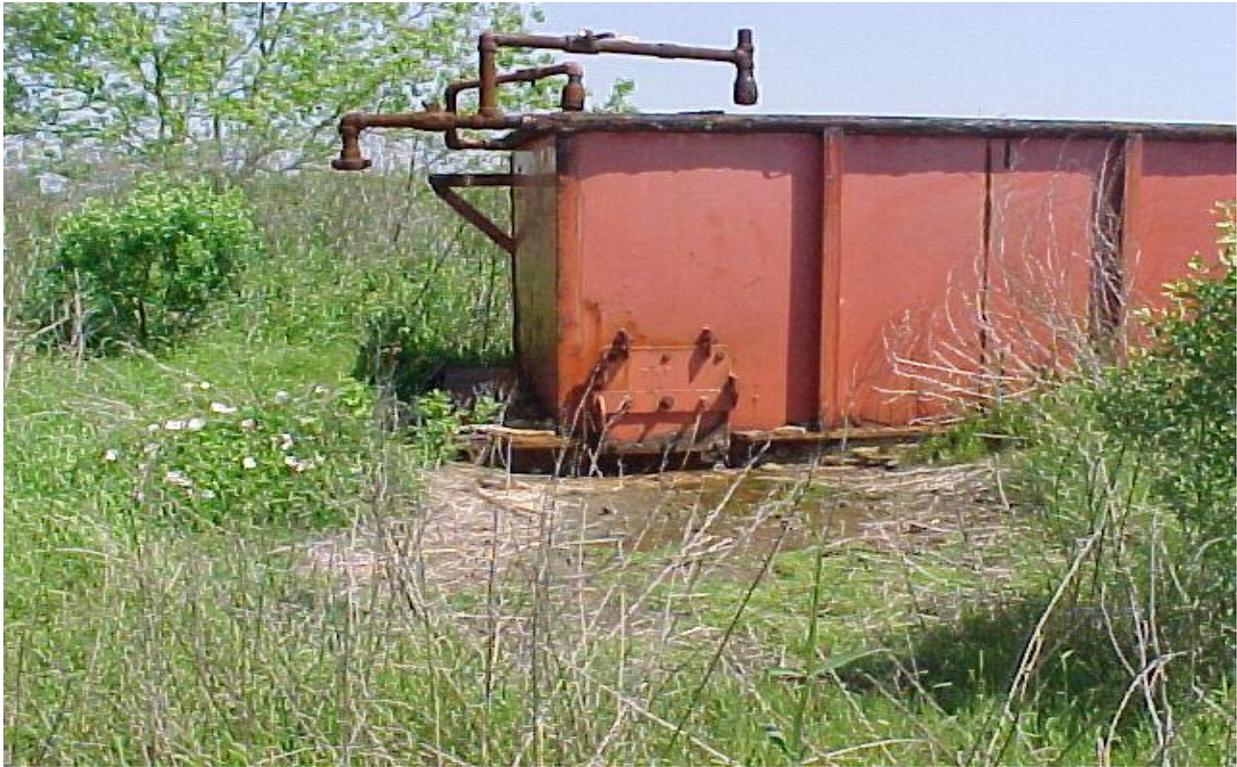
**Photograph No. 9– Former D & G Operating Company, Evans Unit Well #1, Winnie, TX**  
View of the steel workover tank inside fenced area. Note corrosion and leaking from tank.  
Facing Northeast (MSH 04/14/04)

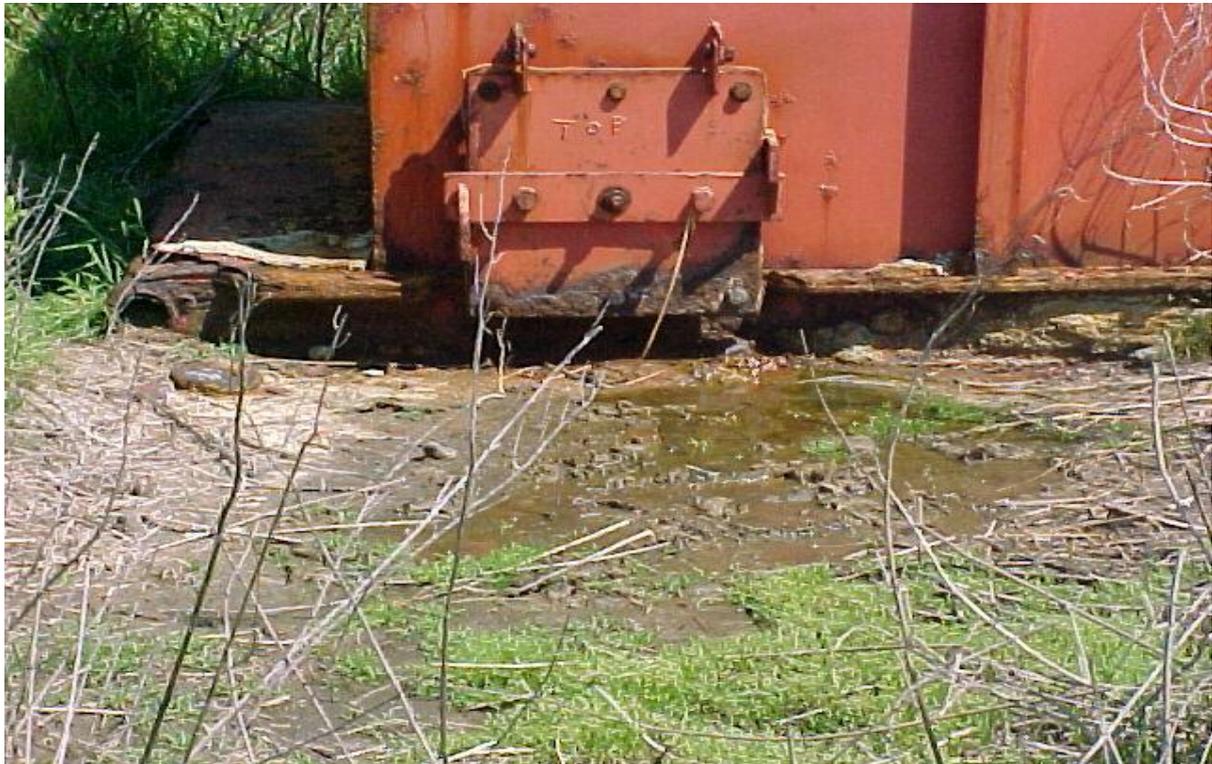
**Photograph No. 10 – Former D & G Operating Company, Evans Unit Well #1, Winnie, TX**  
View of corrosion and water leaking from workover tank. Facing North (MSH 04/14/04)

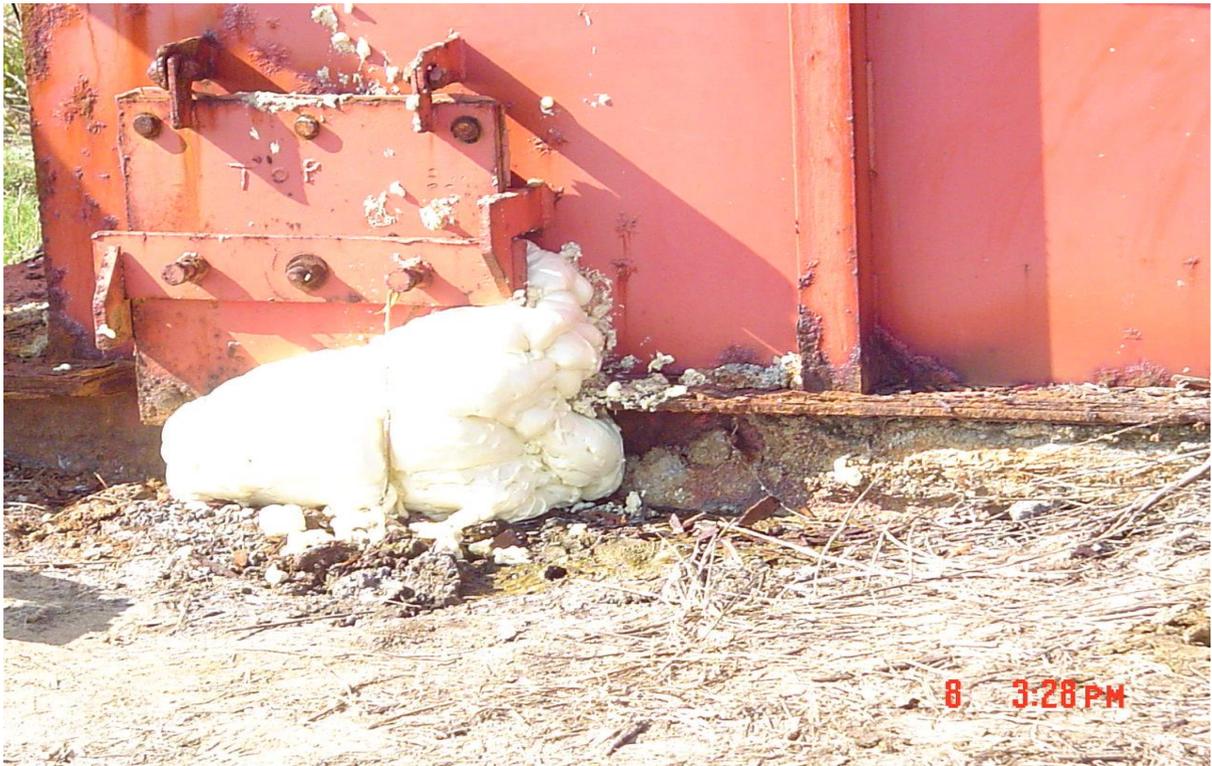
**Photograph No. 11 – Former D & G Operating Company, Evans Unit Well #1, Winnie, TX**  
View of expandable foam insulation used to stop leak from workover tank. Facing North (JW 09/08/04)

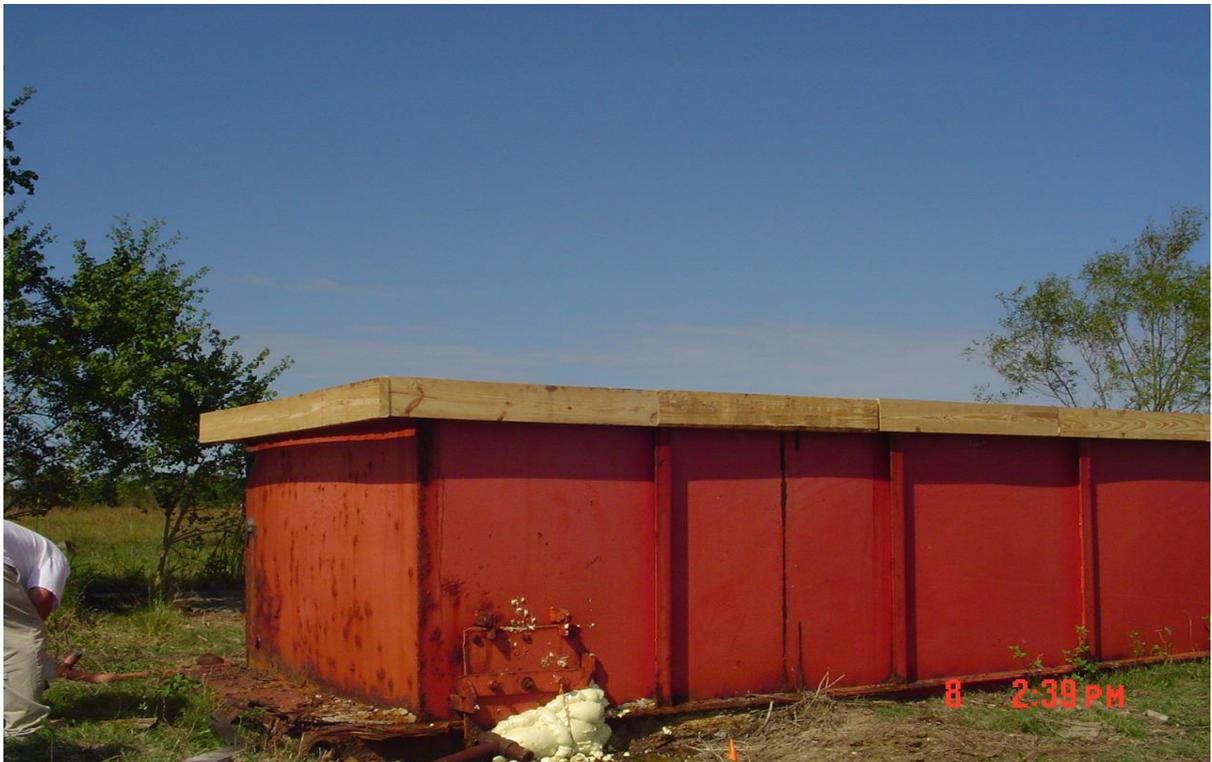
**Photograph No. 12 – Former D & G Operating Company, Evans Unit Well #1, Winnie, TX**  
View of wooden cover constructed to prevent additional rainwater from overfilling workover tank.  
The wooden cover was later covered with a tarp. Facing North (JW 09/08/04)

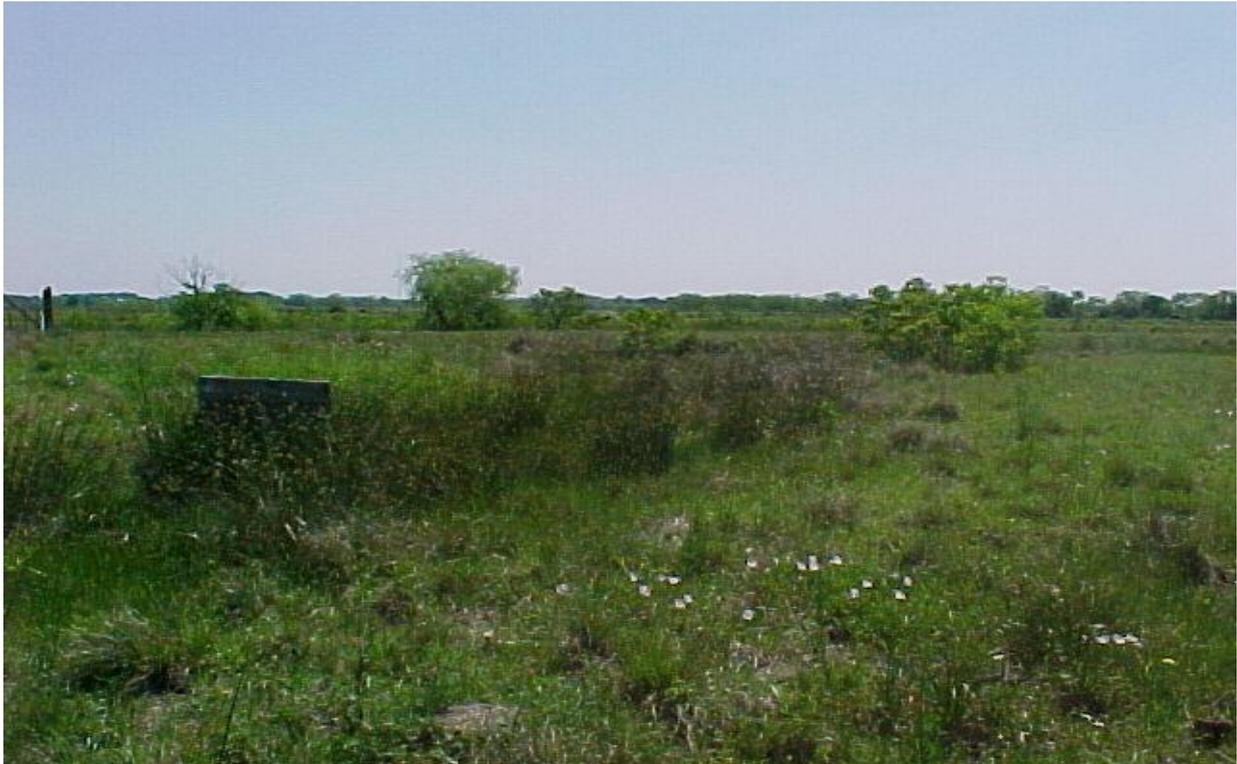
**Photograph No. 13 – Former D & G Operating Company, Evans Unit Well #1, Winnie, TX**  
View of shallow drainage ditch (to left) running along southern boundary of fenced area.  
Facing West (MSH 04/14/04)
