**REMEDIATION OVERSIGHT REPORT
FOR THE
D&G OPERATING CO., INC.
NO. 1 EVANS UNIT WELLSITE
NEAR WINNIE, TEXAS**

August 2007

**OVERSIGHT REPORT
FOR THE EVANS UNIT WELLSITE**

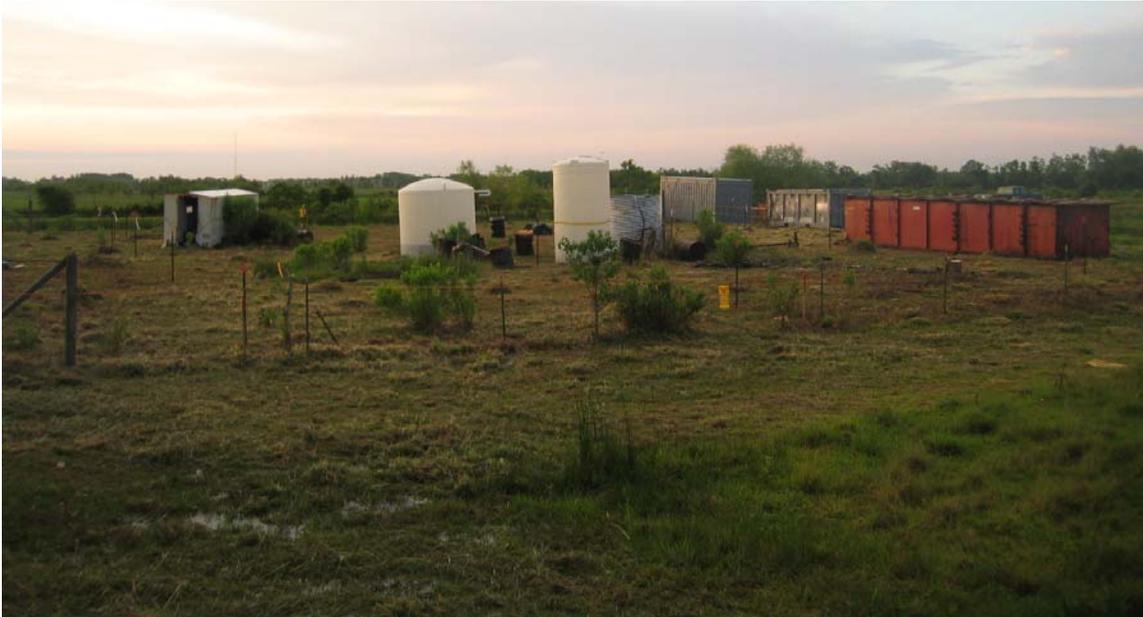
Cover Photo

Shows the contaminated area containing (from left to right) the tool trailer, poly tanks with drums between them, the well head encased by a 6 foot diameter corrugated pipe filled with cement, two gray storage containers in the background which were brought by EnergySolutions, and the workover tank (red).

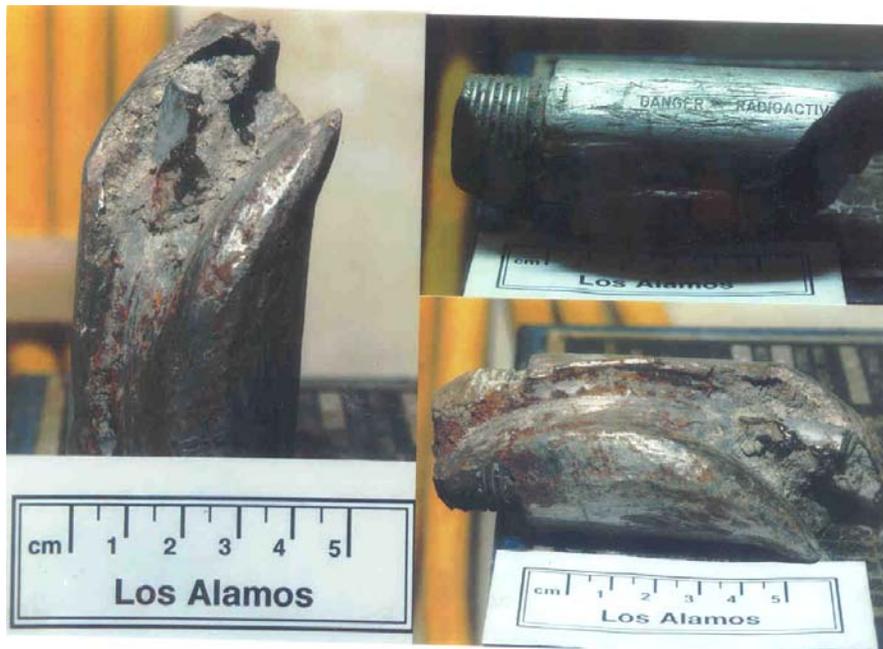
Figure 1. Damaged Source

A logging tool containing a three-curie americium-241 (Am-241)/beryllium radioactive source became stuck in Well No. 1 at the D&G Operating Co., Inc. No. 1 Evans Unit wellsite 1.5 miles north of Winnie, Texas in Chambers County. During recovery operations, the source ruptured and resulted in contamination of the well, associated equipment, and the surface soil; the composite photo below shows the damage to the source capsule. The cover photo was taken near the beginning of the remediation and shows most of the surface objects which had to be removed for soil excavation; not visible is the pile of 40-some pipes which were covered with grass and other vegetation. The cover photo also shows the fence which had been constructed around a rectangular area of the site approximately 130 feet by 115 feet, which included the well and the area of known contamination. The Texas Railroad Commission Oil and Gas Division (the Commission) contracted EnergySolutions, a remediation firm, to excavate and remove contaminated material from the site in order to release the area for unrestricted use in accordance with State of Texas, Department of State Health Services (DSHS) requirements.

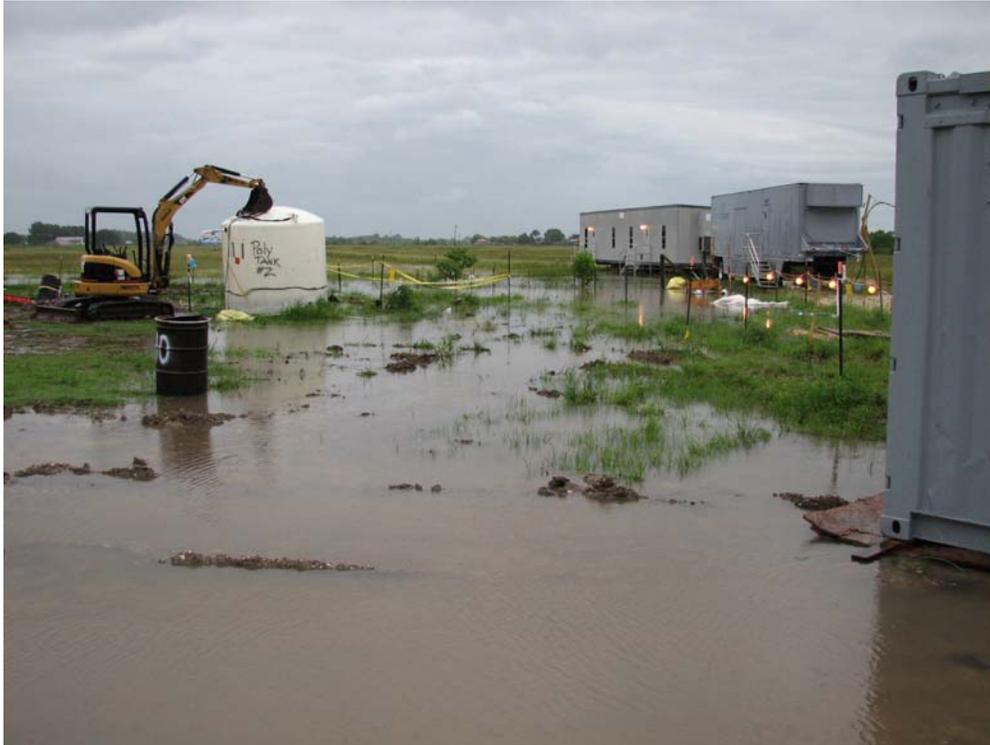
Figure 3. Flooded RCA on July 4th, 2007

Setup of the site and subsequent work was always dependent upon rain. As the interval between rain days was short, the soil tended to remain saturated; the work was stopped frequently due to rain and storm events. The following photo shows the flooded RCA during the week of July 4th, 2007.

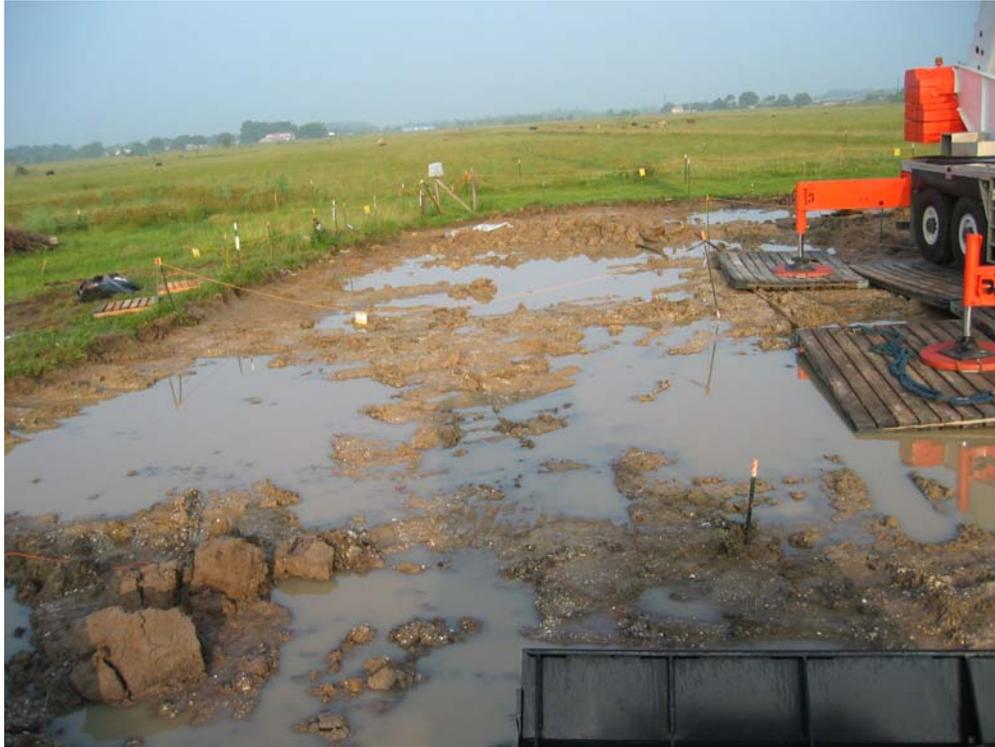
Figure 4. Pooling of Surface Water

As shown in the following photo, surface water will pool wherever soil is removed. Often soil was piled near the track hoe to permit water drainage overnight. Please note that this issue required a great deal of attention as *EnergySolutions* was required to package and ship all containers without any standing water in them per US Department of Transportation regulations.

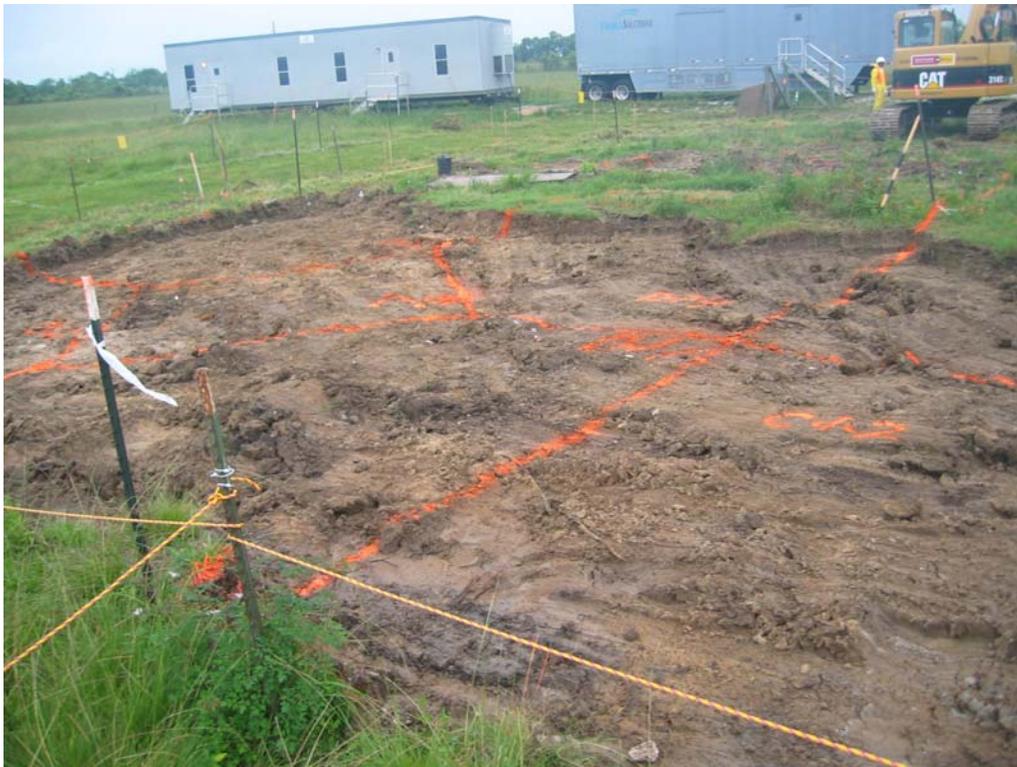
Figure 5. Excavated Workover Tank Area

A strategy was developed to perform slightly deeper than 6" lifts of the areas with the higher known contamination levels, e.g., the workover tank area and the wellhead; see the following photo. This approach reduced potential exposure to personnel while affording a pooling area for any surface water. The excavation then proceeded to the east part of the site where Columns A and B which did not require as deep of a lift as those that were made at the workover tank area. RCA Columns A and B were the first areas to be remediated and partially backfilled. A benefit was that any runoff would go to the workover tank area and not toward a clean area. Columns C, and D-E were then excavated in a north to south direction which permitted most rain to pool in those excavated areas; most liquids evaporated or drained over several days. Finally, the vegetation was cut in the drainage ditch area, and the grass roots and topsoil to about 3" were removed between the areas designated in the RFP as Ditch 1 and Ditch 6. The grasses in the ditch appeared to act as it own erosion control as contamination was identified along the northern edge of it, an area immediately down slope from the RCA. Working in this manner, maintained control of remediated grids until backfill could be accomplished.

No water was collected and pumped to an existing drainage ditch. Water from Grid D4 was pumped to a 500 gallon poly tank to no avail as the water level was not reduced; this water was immediately returned to the grid.

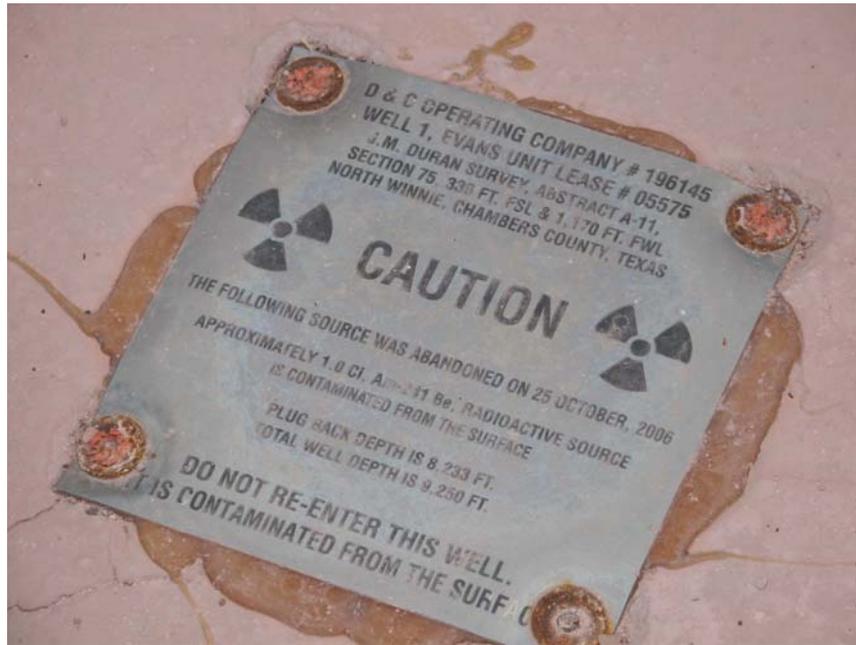
Figure 6. Radiation Caution Sign on Wellhead Monolith

The well-head was encased with a ~6' diameter by ~6' tall corrugated pipe filled with concrete (dyed pink) to within two feet of the top. Photos of the corrugated pipe containing the monolith are presented in the cover photo and Figure 2 above. On top of the monolith was a radiation caution sign and a photo of that sign is provided below. Excavation under the monolith was required as it had been placed over an area which contained contamination greater than 6 pCi/g. It was deemed unsafe to simply excavate under the monolith (perhaps with hand digging) so it was removed. The monolith was broken into many small pieces using the track hoe with a pneumatic jack hammer attached. Results of two concrete samples were reported by EnergySolutions as positively identified with Am-241 concentrations but less than 1 pCi/g; the concrete was packaged in a metal container and sent to the EnergySolutions' site in Clive, Utah for burial. Note as reasoning for considering the concrete to be buried offsite as radioactive material that there was only a release criterion for soil and not other material such as concrete; further, a timely agreement between the Texas Department of State Health Services or perhaps the Texas Commission on Environmental Quality (TCEQ) to meet the Commission's schedule was not considered favorably. Also, EnergySolutions reported that their decommissioning license required them to consider the concrete as licensed material which must be dealt with as radioactive waste. The caution sign was reported by EnergySolutions as placed on the new replacement monolith; see Figure 6 below.

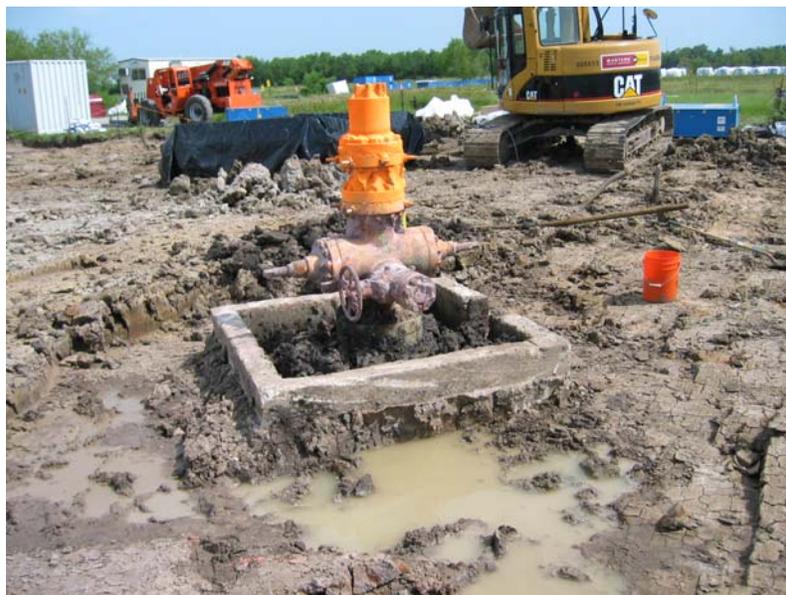
Figure 8. Wellhead With the Top of Cellar Showing

EnergySolutions was working on the wellhead area on 31 July 2007 and discovered that a cellar existed with highly contaminated clay/soil inside of it. Three samples were collected near the 12 inch depth and the results were reported as 796, 223 and 22 pCi/g. The cellar is 6'x6' by 3' deep, it has a bottom, and the cellar walls are 6" thick. After cleaning out an ~1 foot depth of soil and clay like material, an additional composite sample was collected on 5 August 2007 from all four cellar corners with an analysis result of 23.9 pCi/g. A weighted average of 4.5 pCi/g of the Grid C2 including the cellar result was deemed as acceptable by DSHS; no further excavation was required in the cellar.

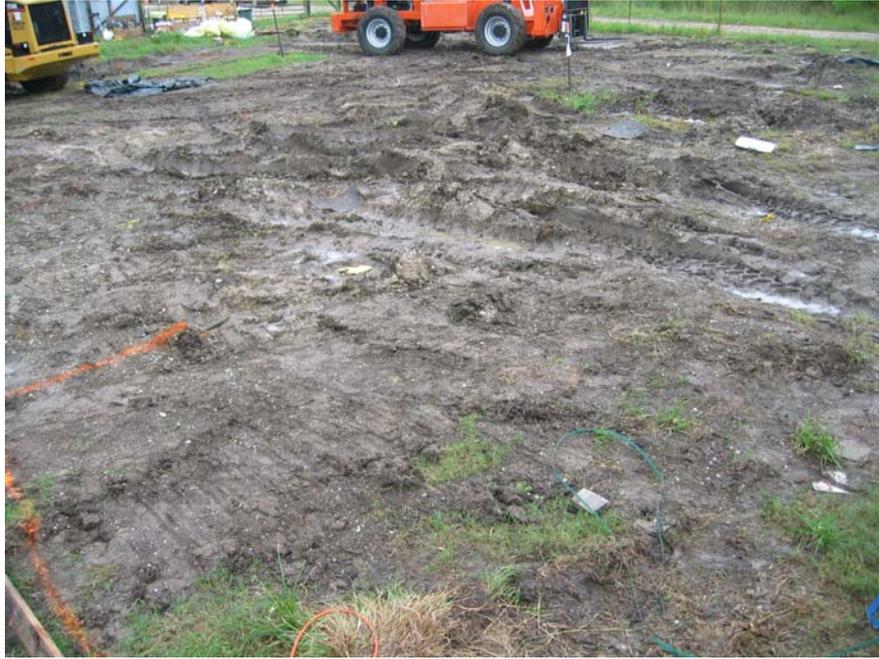
Figure 9. Illustration of Rutting by Forklift

There was a secondary problem with the forklifts as they caused rutting which is discussed in the next section. However, the replacement of the forklifts did not eliminate the rutting of the soil as the tires on the replacements appeared to be narrower which could make rutting worse. The replacement forklift inside the RCA was used to move bags in the drier areas (less rutting) with Commission onsite approval through the following Sunday. The crane discussed in the following section was procured because of the rutting and not due to the lifting capacity of the replacement forklifts.

A large industrial wheeled fork lift, discussed above, was initially used within the fenced RCA to transport filled soil bags. It was noted that field conditions were deteriorating and deep ruts were made as the fork lift carrying up to 11,000 pounds traversed the grids in wet soil; see photo below. It was feared that contamination on the tires could potentially cross contaminate grid areas and soil layers within a grid; the use of fork lifts in the gridded areas was ordered stopped by the Commission on July 20, 2007. Selective use was afforded by the Commission on July 21 and 22, 2007. Whether or not cross contamination contributed to the total excavated volume is not determined. Use of a crane was initiated on July 23, 2007.

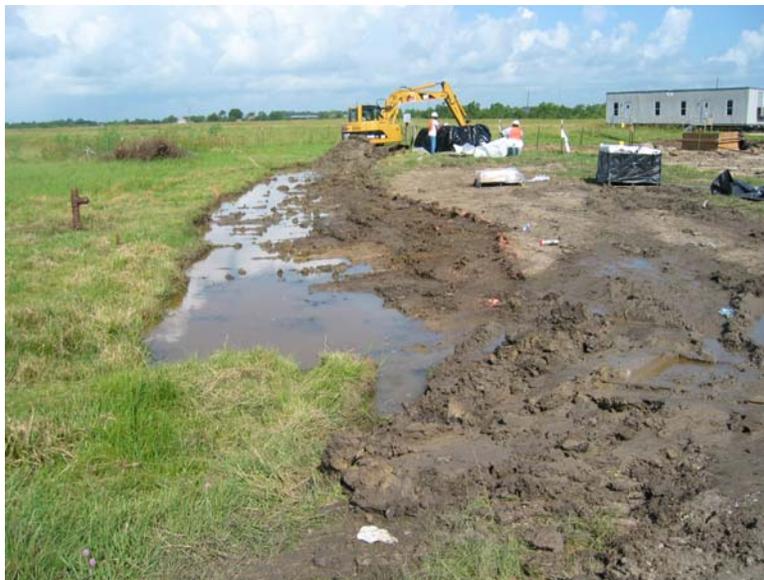
Figure 10. Excavation of Drainage Ditch

Scanning by *EnergySolutions* and ChesNuc of the drainage ditch indicated elevated concentrations between the RFP sampling locations of Ditch 1 and Ditch 6. *EnergySolutions* excavated an approximate 4" lift from the entire length between these locations; see below photo. Note that this work was considered as part of a continuing verbal change order by the Commission as the RFP indicated that only areas designated as Ditch 1 and Ditch 6 were contaminated above the release criterion. The verbal change order was placed in effect post the initial contract for 465 cubic yards.

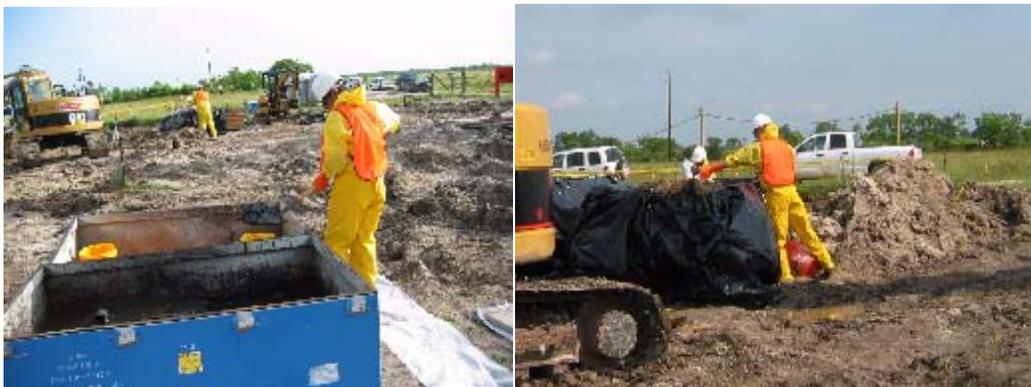
Figure 11. (1) Transfer of the Sediment Into Small Bags and (2) Placing the Sediment Into A 5 yd³ Soil Bag

The sediment was removed from the workover tank and the workover tank dismantled during a period when ChesNuc were not assigned to the site. The work reportedly involved hand shoveling, back hoe work, and vacuuming the sediment into small metal boxes. The workover box was reported to be cut up into smaller sections with an electric torch; spayed with a mixture of glue to reduce or eliminate the spread of contamination, and carried to a large roll-off box for ultimate disposal. As stated earlier, it was reported by EnergySolutions that transport of the sections of the workover tank involved several grids spanning E1 to A3.

For the sediment, the safest course of action was probably that selected; place small bags containing sediment into several routine soil bags for dilution and then shipment. EnergySolutions calculated the weight of sediment that could be mixed into an individual bag and this occurred with soil bags numbered 68 through 108. The following composite photo illustrates the transfer technique from the B-12 containers to the regular soil bags.

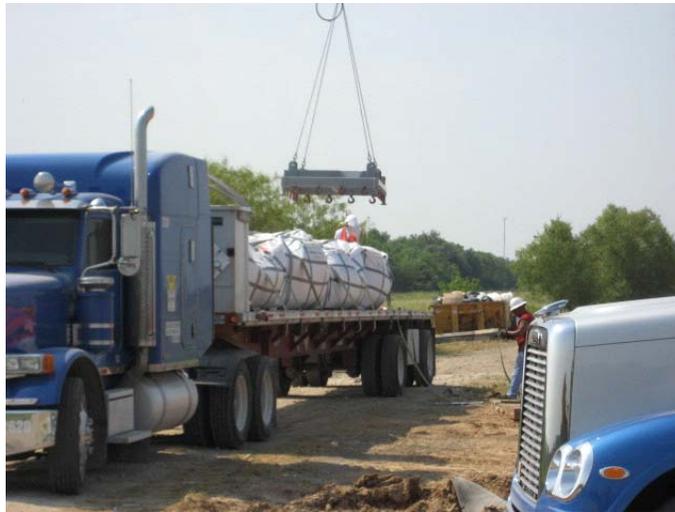
Figure 12. Loading Soil Bags for Transport to Houston Railroad

The following Figure 12 illustrates the soil bags being loaded for transport by truck to the Houston rail yard where they were to be transferred to gondolas for shipment by rail for burial at Clive, Utah. Figure 13 shows metal containers with the solidified liquids and other surface contaminated objects Loaded on a truck. Figure 14 shows part of the backfill work with clean soil.

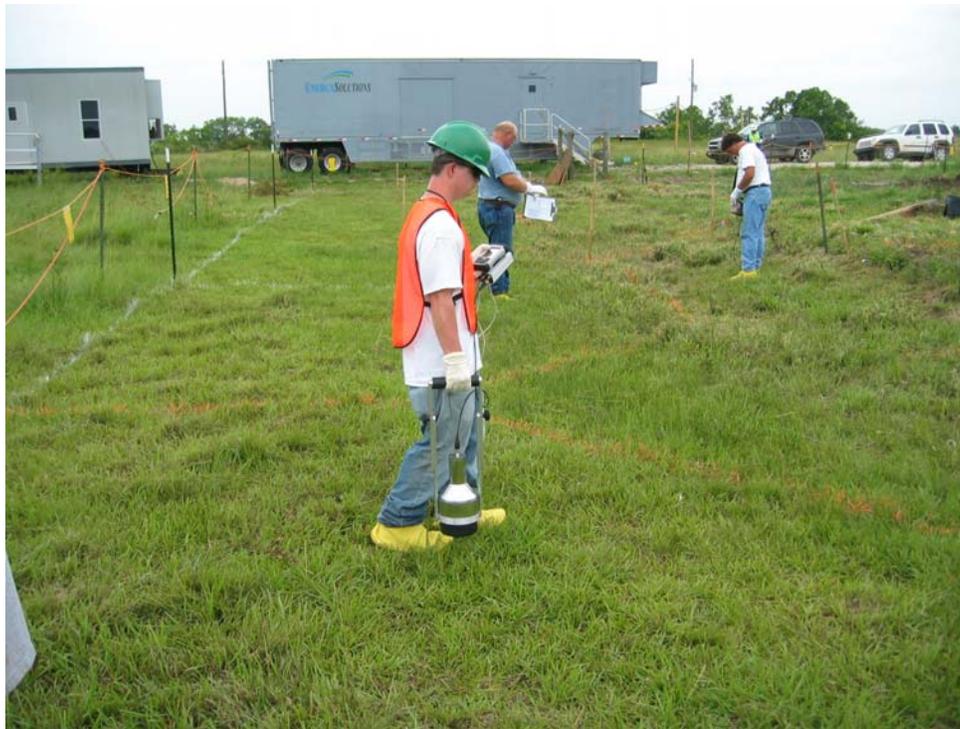
Figure 15. Scanning With A FIDLER

As a standard practice by EnergySolutions, the areas within the RCA received a 100% scan using the FIDLER probe following each 6 inch lift. ChesNuc's instrumentation was proven more sensitive in field use and scans were made to supplement the EnergySolutions' scans. Drawing 4 in Appendix C shows several elevated areas (orange dots) identified by ChesNuc scans which were removed by EnergySolutions. Most of the scan measurements were recorded by ChesNuc along with the GPS coordinates. Certain of the areas do not indicate measurements due to GPS not being available but all were scanned except where standing water made the survey null.

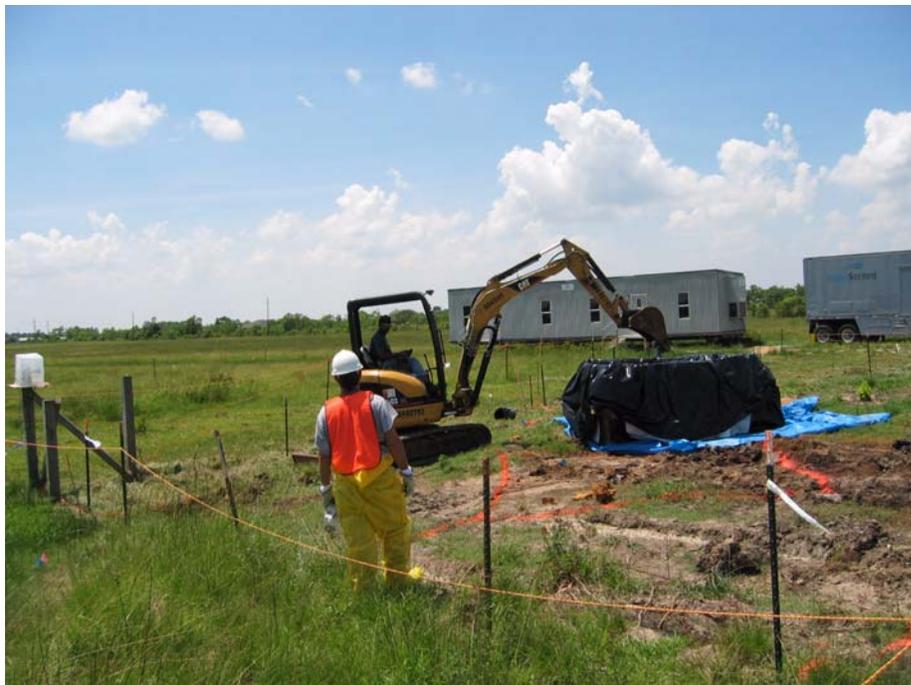
Twenty-one soil bags were filled 7/12-15. The weights and concentrations that were available at report time are attached in a table. Figure 1 below shows the filling of one; only the inner plastic liner is visible here. A drawing is also attached indicating where excavation took place this week.

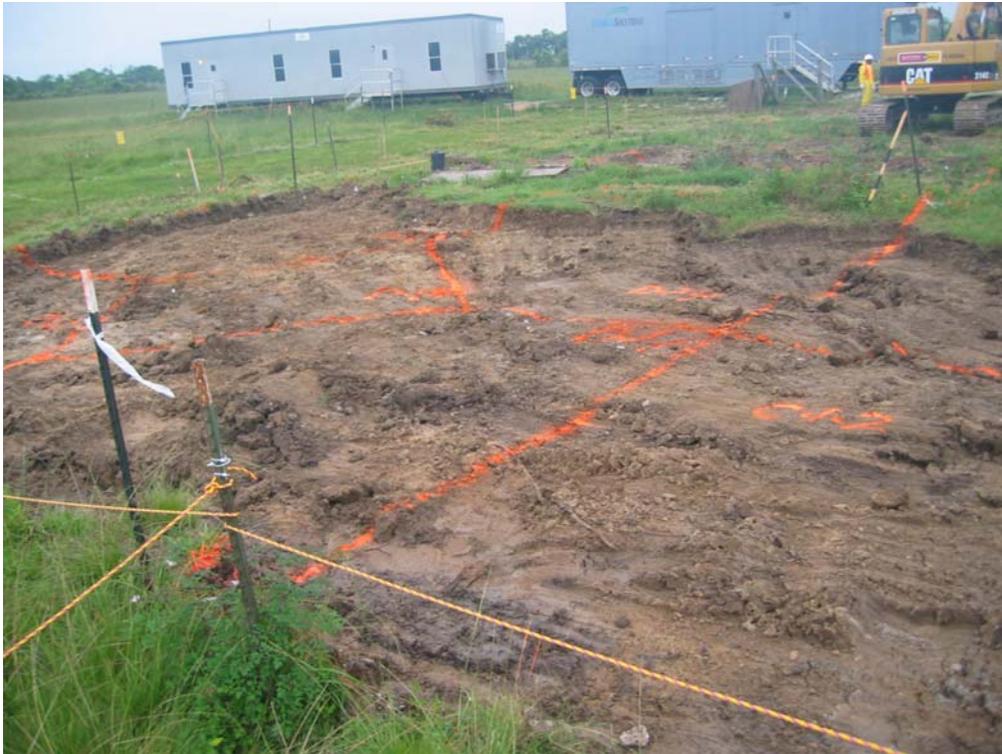
Figure 2 below shows Cell D-1 (to the left) and part of Cell C-1 after the first lift.

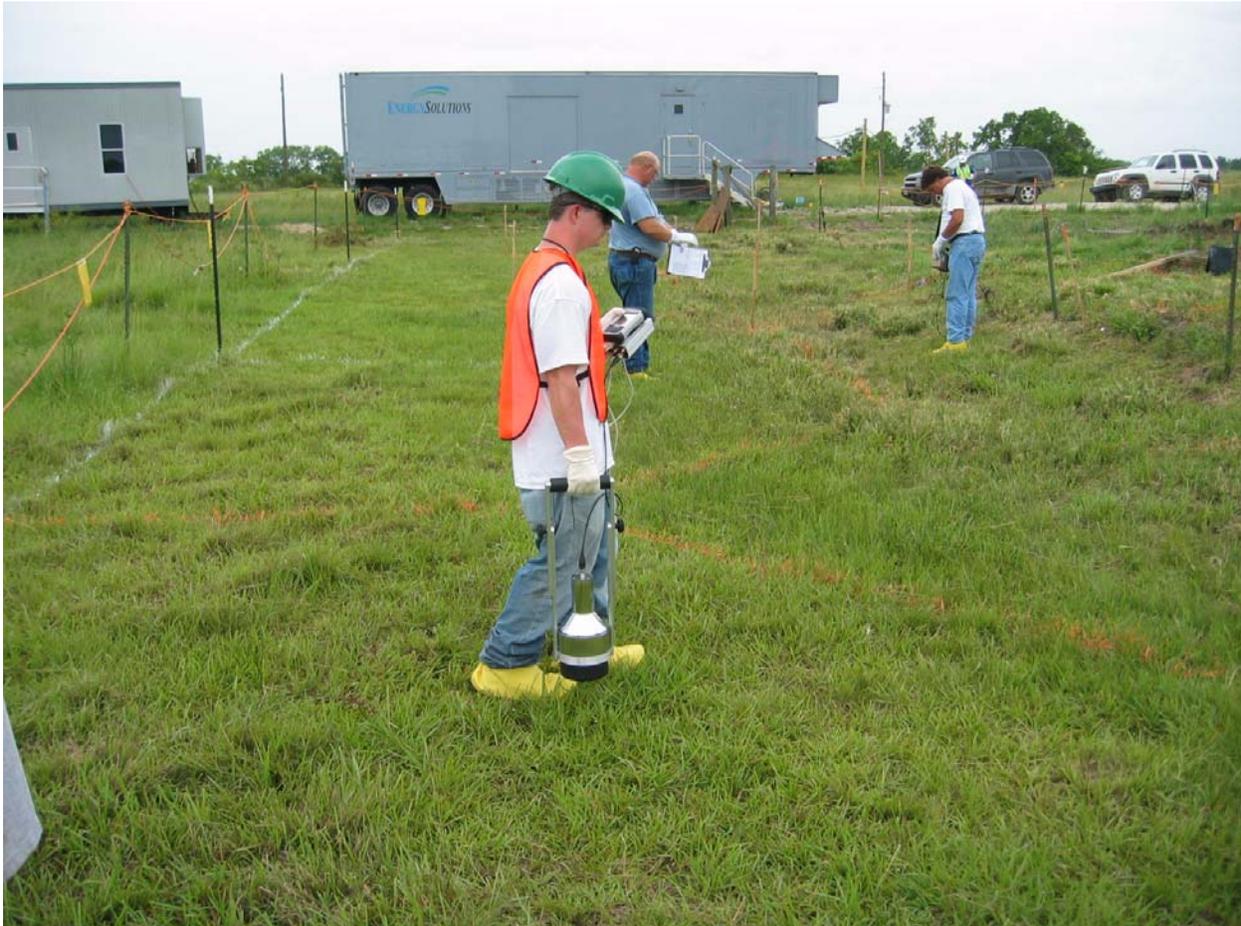
Grid areas E-1 through E-4 were scanned with FIDLER probe detectors which are sensitive to Am-241 gamma energy. ES determined that contamination was identified >6 pCi/g in the 20 m² sub-cells 1, East half of 3, and 4 in each of the Cells E1, E2, E3, and E4. There is a sloping drainage ditch (see small valley between the surveyors in Figure 4 below) which separates these cells from the western half of the E cells and contamination has been found only on the eastern side; one exception being Cell E-1 while Cell E-0 has not been fully scanned. Note that excavation of the sub-cell 3's is planned in only the eastern half of each pending acceptance of a QAPP change.

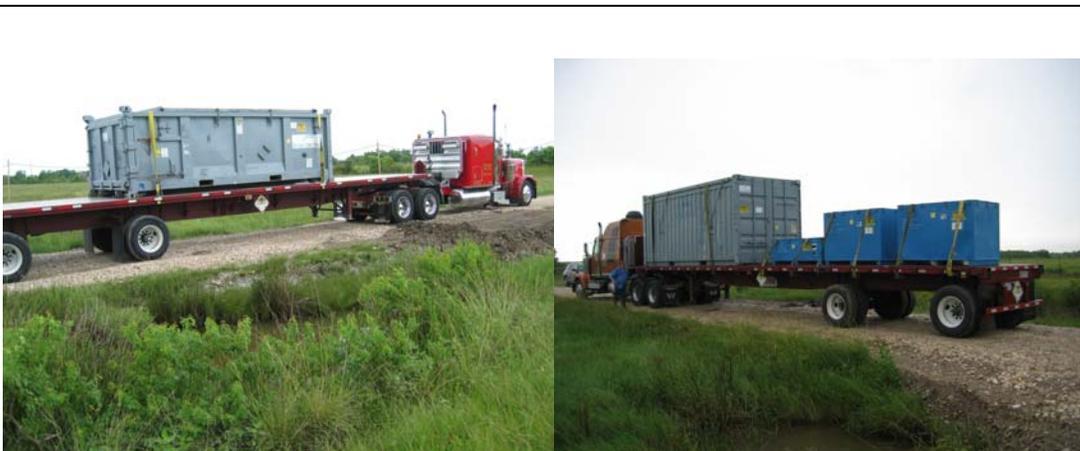
- Two waste shipments were made Thursday to Clive, Utah consisting of one roll off box on one truck and one C-Lan box, 2 B-25 boxes and one B-12 box on the second. Volumes for the roll off – 675 ft³, C-Lan- 1,280 ft³, B-25 box - 95 ft³, and the B-12 box – 45 ft³. See figures below.

Figures 1&2 Waste Loaded on Hittman Trucks to Clive, Utah

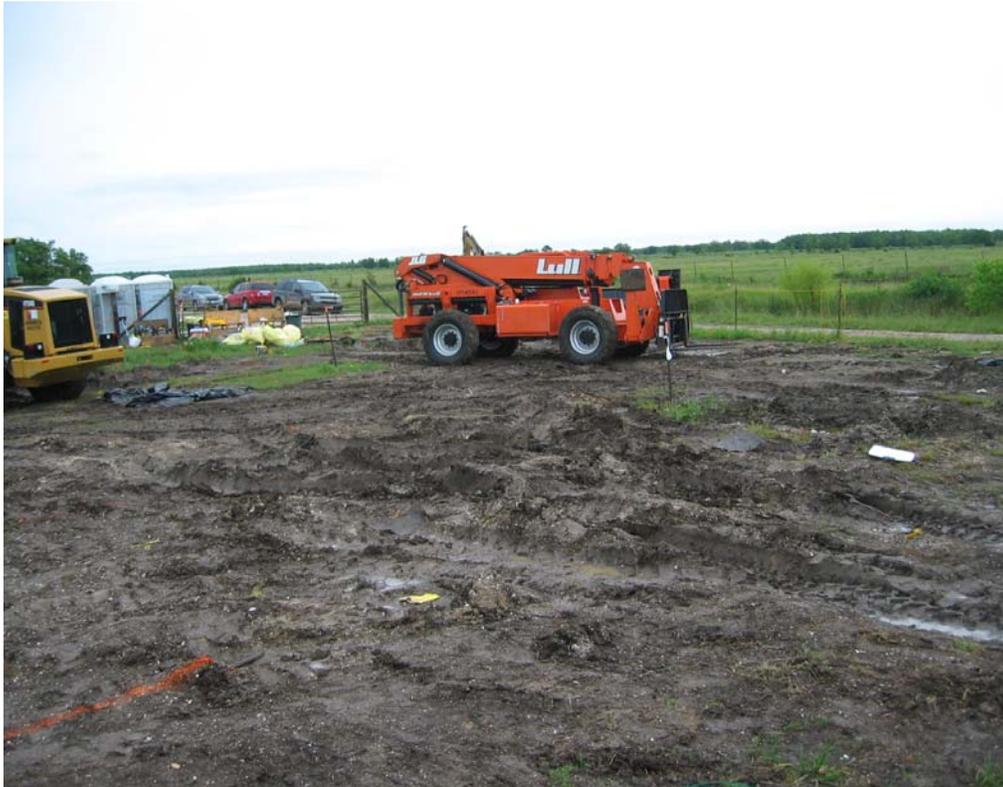
Figure 3, Deep Ruts In Approximate Center of Grids (Looking NE)

- Thursday, work stopped due to rain at 0930, resumed about 12:30.
 - Work stopped about 1 pm on Friday due to rain.
- The tires on the fork lifts are making ruts in the wet soil, routinely > 6" deep, and occasionally getting stuck. This creates a potential for cross contamination from one grid area to another; also from one layer to one or more layers below. See the following photos 3 and 4 illustrating the deep rutting. On Friday, Byron Krysher, RRC, requested M. Pries to limit moving bags across the grid areas to reduce potential of cross contamination. Work in the A grids was performed under Mr. Fisher's observation on Saturday and Sunday.

- Although both fork lifts have been replaced with those that can safely handle the weight of a filled bag, the new lifts did not solve the rutting issue. ES has ordered a large crane to lift an individual bag from the point of fill to outside the grid area. The crane is expected to be setup and operational before noon on Monday, July 23; at that time, the excavator will be the only moving piece of equipment in the grid area. These changes will eliminate the current rutting problem and improve bag handling efficiency as the crane can also weigh the bags. The bags had been weighed after they were transferred outside the grid area; time will be saved.

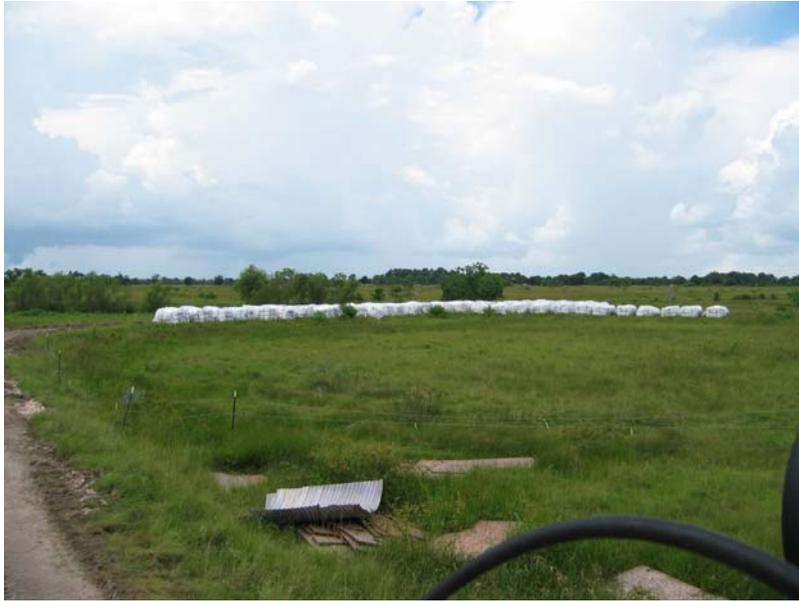
- With this week's effort of filling 47 soil bags, ES has placed a total of ~440 yd³ of contaminated soil into 91 bags for shipment; 96% of the contract estimate of 465 yd³. Attached is a listing of the filled bags, the date filled, the grids excavated, weight and concentration as known at report time. In-scope sediment was placed into several bags and completed; discussed in detail below. The following photo shows the bags stored for shipment.

Figure 1. Filled Soil Bags Stored At Site

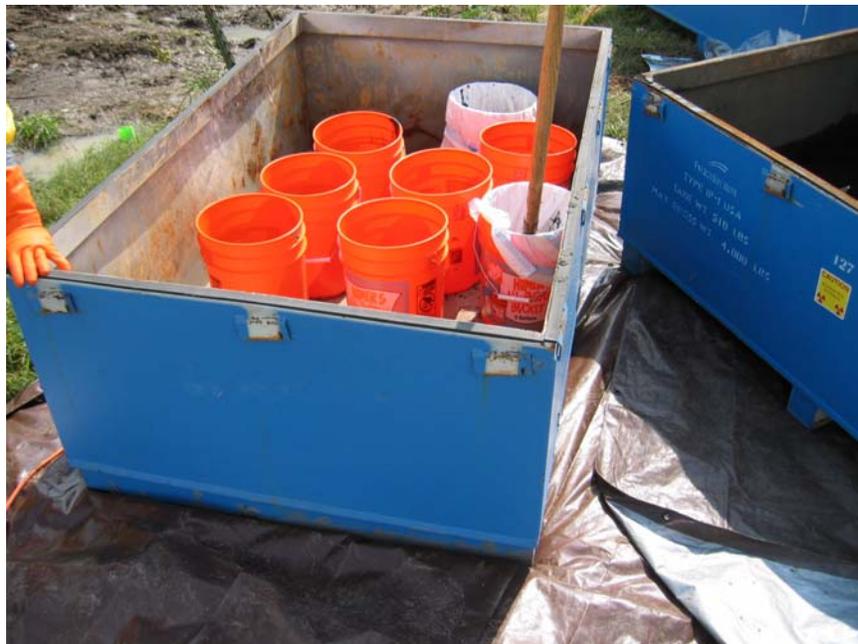
- ES has presented soil sampling results for several grid areas, see attached drawings. Results of soil sampling for most are still pending. These areas were independently scanned by ES and ChesNuc and no elevated areas were identified. Control ropes were hung to preclude additional traffic in the areas. Soil sampling results are presented in the following table. Mr. Krysher informed Mr. Pries on 7/25 that backfilling could be performed as areas are confirmed to be < 6 pCi/g.
- The in-scope sediment (2 yd^3) was placed into soil bags this week. The sediment was hand shoveled into plastic lined 5-gallon pails with the pail contents distributed over 23 soil bags. See the following three photos.

Figure 2. Pails Used For Sediment Transport To Bags

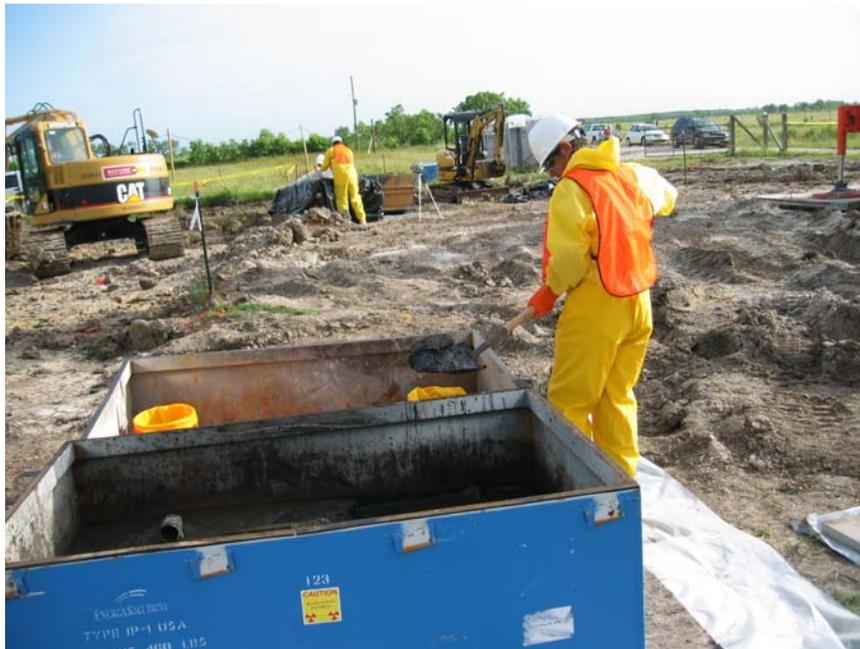
Figure 3. Sediment Transfer Into Pails

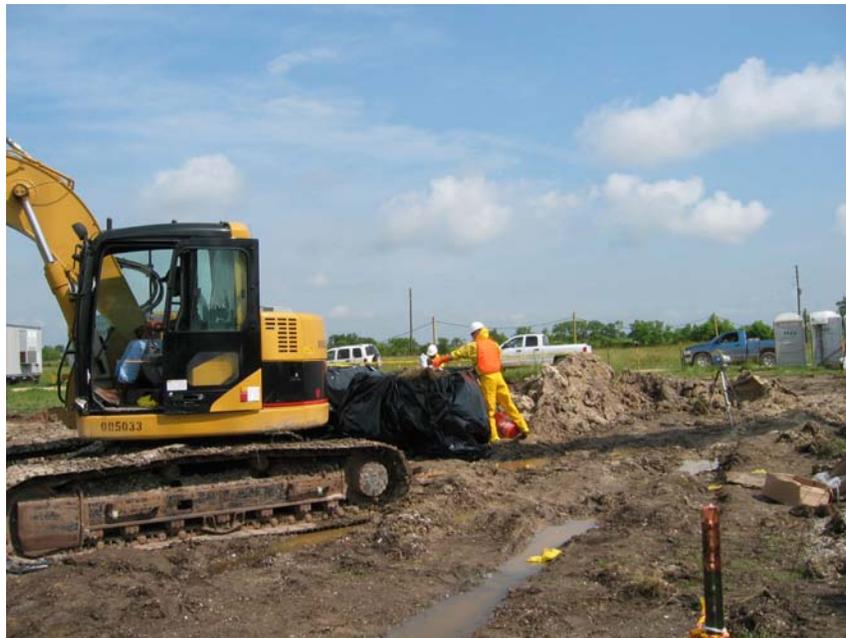
Figure 4. Placing Sediment In Soil Bag

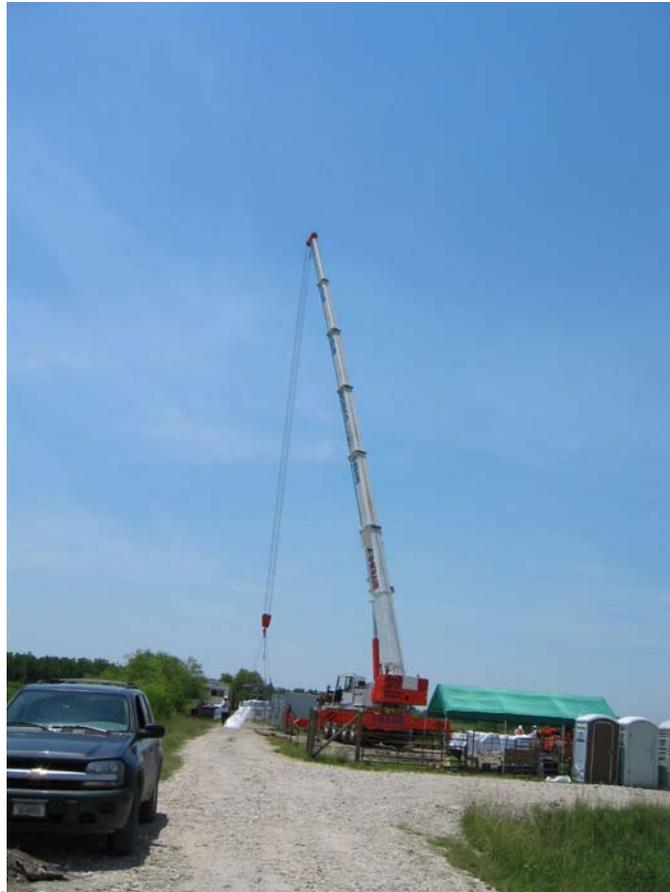
On 7-23, a crane was setup in Row A to lift the soil bags from the work area to the roadway. As the reach of the crane for the weight of the bags is ~75 feet, it will be moved into Row B and then Row C as necessary. The use of the crane versus fork lifts will significantly decrease the cross contamination of grids and layers in grids. See photo below showing the crane in operation.

Figure 5. Crane Lifting Soil Bag to Road

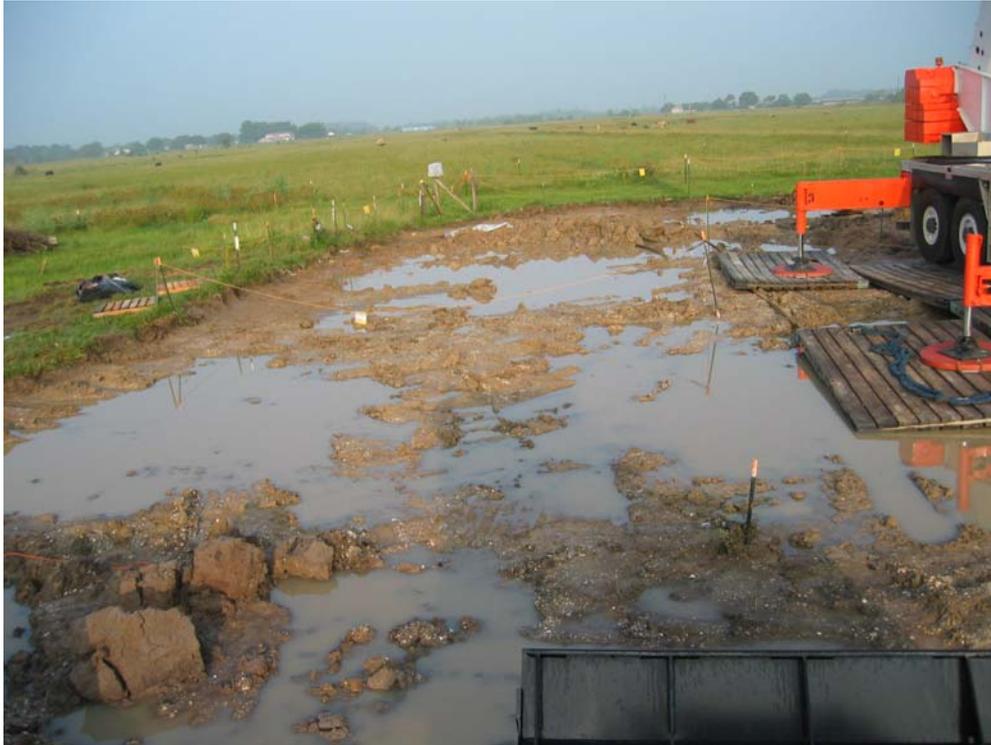
Figure 1. Pooling of Surface Water

- As shown in the photo, surface water will pool wherever soil is removed. Mr. Fisher has indicated that it is permissible to release an area based only upon soil sample results if the areas can not be dried and scanned thoroughly. ChesNuc is not to slow backfill efforts due to standing water or lack of scanning.

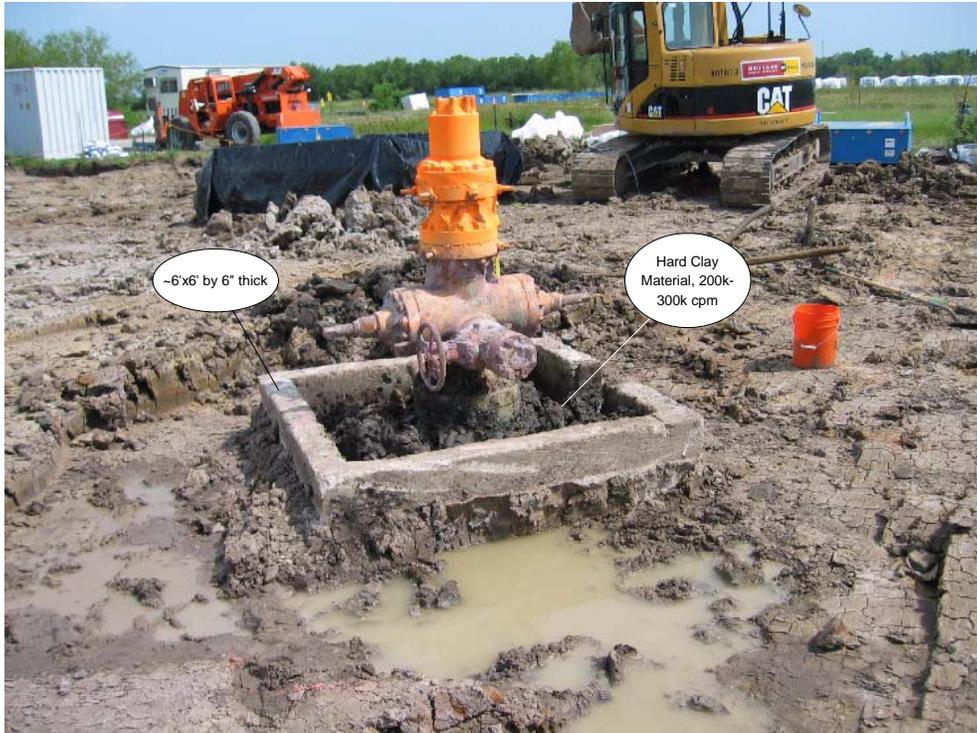
Figure 2, Well Head Photo With Top of Cellar Showing

- ES was working on the wellhead area on 7/31 and discovered that a cellar existed with highly contaminated clay/soil inside of it. Three samples were collected near the 12 inch depth and the results were reported as 796, 223 and 22 pCi/g. The cellar is 6'x6' by 3' deep and has a bottom; the cellar walls are 6" thick. Cleaning within the cellar walls is difficult as it must be done by hand shoveling in a small space. After cleaning out a 1 foot depth of soil and clay like material, two samples at that level were collected with results of ~1.4 pCi/g and 56.5 pCi/g. An additional composite sample was collected on 8/5 from all four cellar corners but analysis results were not available at report time.

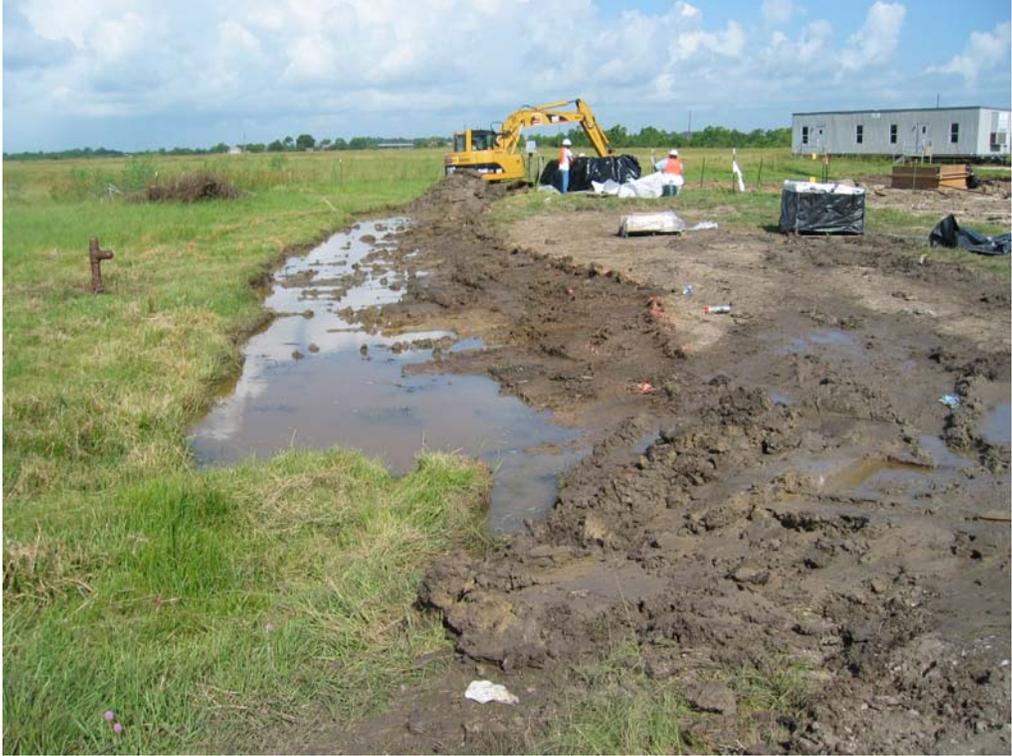
Figure 3, Excavation of Drainage Ditch

- All soil excavation should be completed this week and trucks are scheduled to begin taking soil bags to the Houston rail yard on Tuesday, August 7.
- A 1" to 2" thick concrete pad (~8'x8' and covered with 2" of soil) was discovered in grid C0; sampling above and below the pad did not indicate a radiological concern.
- ChesNuc presented the Supplement to the ES Baseline Survey Report and Mr. Cortez, DSHS, promised a favorable response via e-mail on 8/6.
- Scanning of the drainage ditch indicated elevated concentrations between the RFP sampling locations of Ditch 1 and Ditch 6. ES excavated a lift from the entire length between these locations; see below photo.
