AS-BUILT SUMMARY REPORT

**CAP CONSTRUCTION
STEVE'S OILFIELD SERVICES SITE
KLEBERG COUNTY, TEXAS**

August 20, 2012
Project No. 92107518

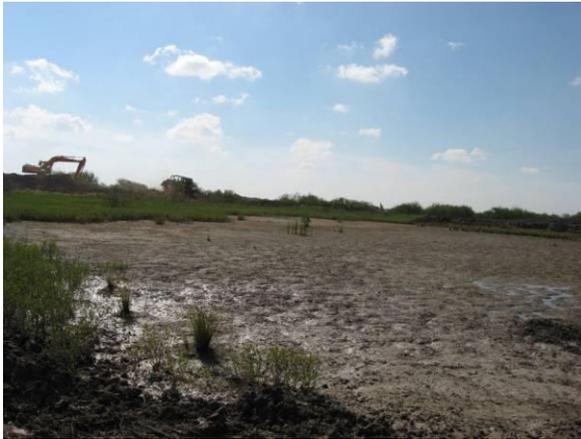
Photo 1 View of pit looking north at start of construction.

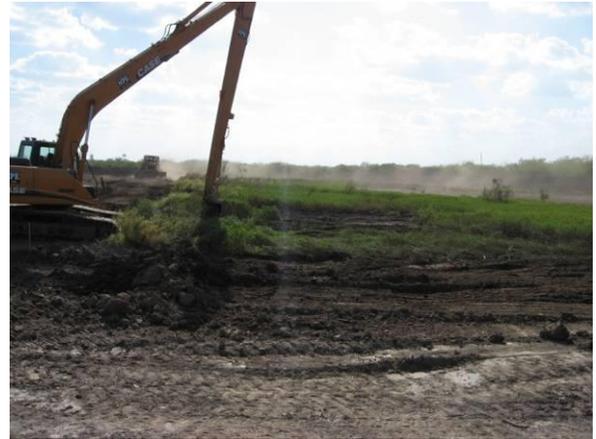
Photo 2 Vegetation being removed from pit surface along west side.

Vegetation cleared from within the limits of the pit was disposed of offsite due to concern it might be contaminated. A total of 500 cubic yards of grubbed material was manifested and disposed of by the Contractor at ECO Mud Disposal, Alice, Texas, a RRC approved disposal facility for oilfield waste. The remainder of the cleared vegetation was dispersed around the site and allowed to degrade.

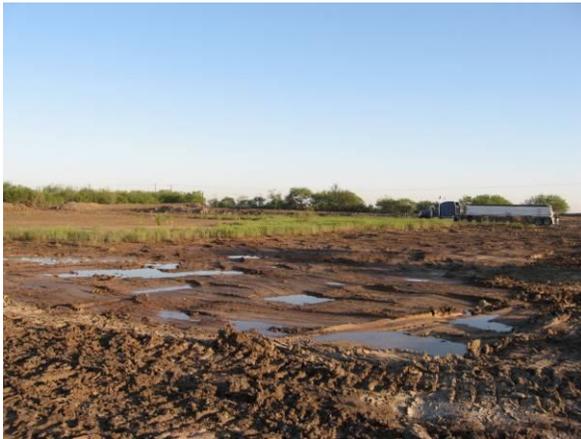
Photo 3 View of pit at SW corner looking NE with vegetation stripped.

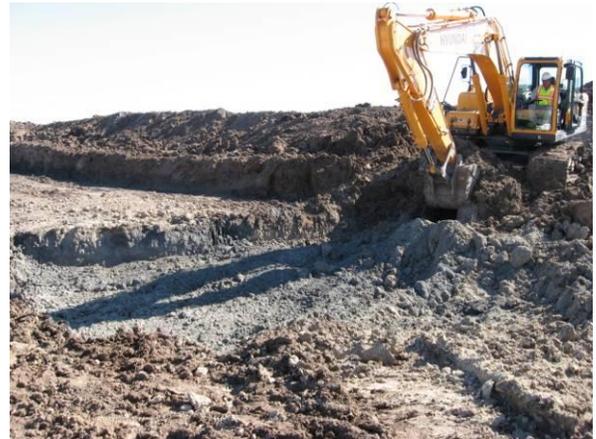
Photo 4 Impacted soil/mud being excavated from west bank.

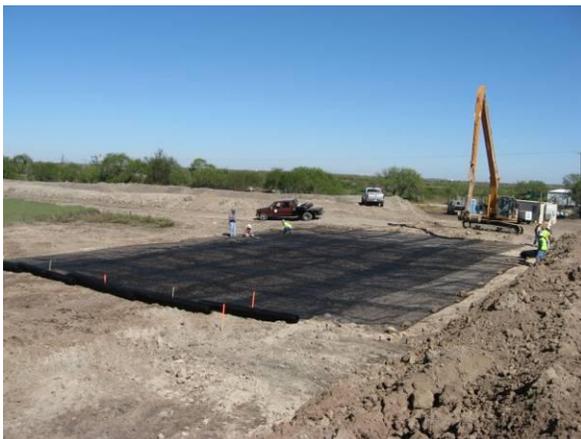
Photo 5 Start of Geogrid placement, southeast corner.

- Cutting the excess soil from the top of the existing berm and stockpiling for reuse.
- Field determining the limits (edges) of the pit.
- Placement of geogrid over the pit area. Provisions were in place for the use of one or two layers of geogrid based on observed field conditions. For the most part only one layer of the BX 1500 geogrid was required, however, along the south side of the pit slightly softer subgrade conditions were observed and two layers of geogrid were placed in that area.

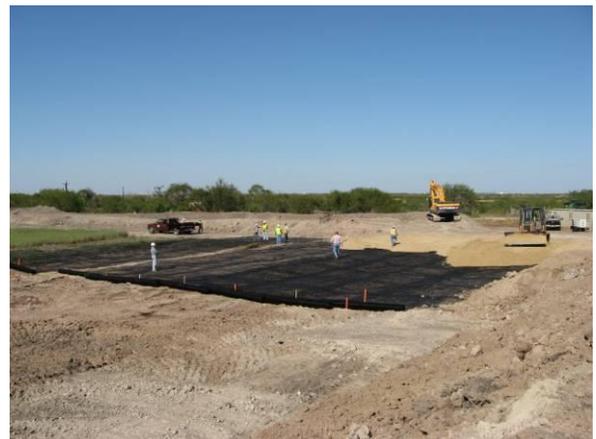
Photo 6 Start of sand placement over Geogrid, southeast corner.

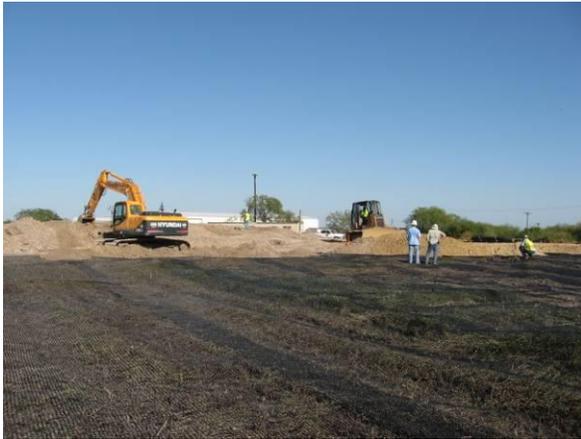
Photo 7 Geogrid placement over vegetation.

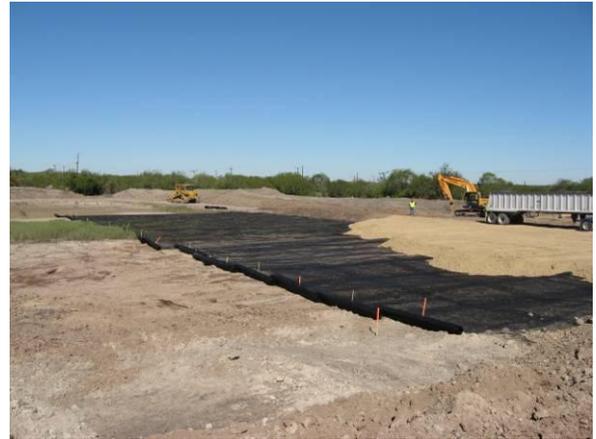
Photo 8 Geogrid and sand placement along NE side of pit.

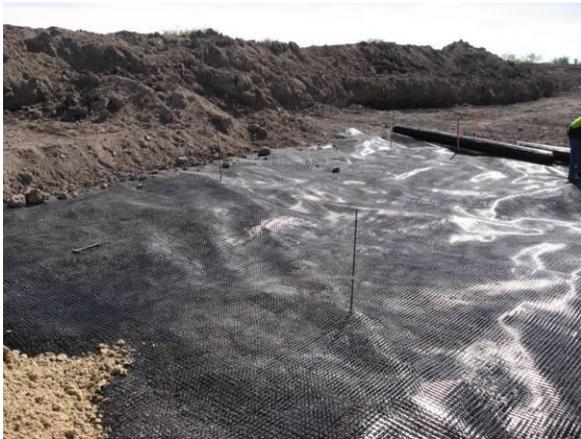
Photo 9 View of grade stake for measuring sand layer thickness.

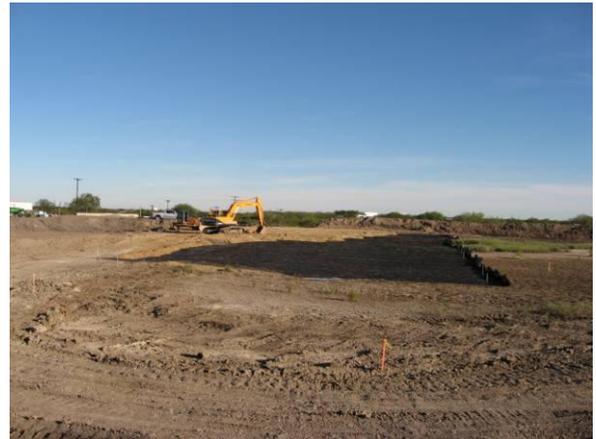
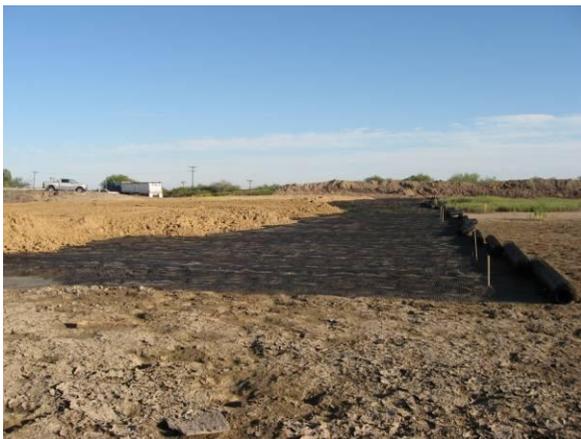
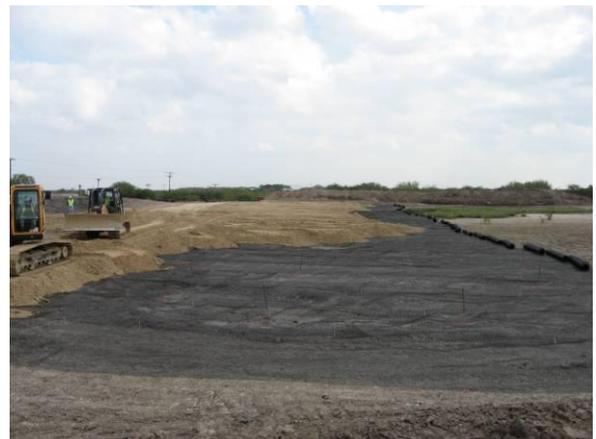
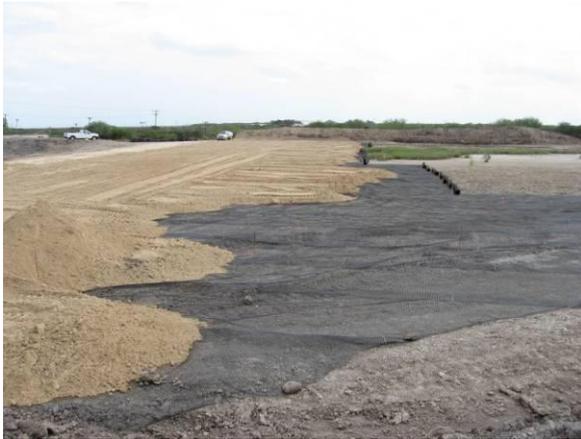
Photo 10 View of Geogrid and sand placement.

Photo 11 View of Geogrid and sand placement.

Photo 12 View of Geogrid and sand placement.

Photo 13 View of Geogrid and sand placement.

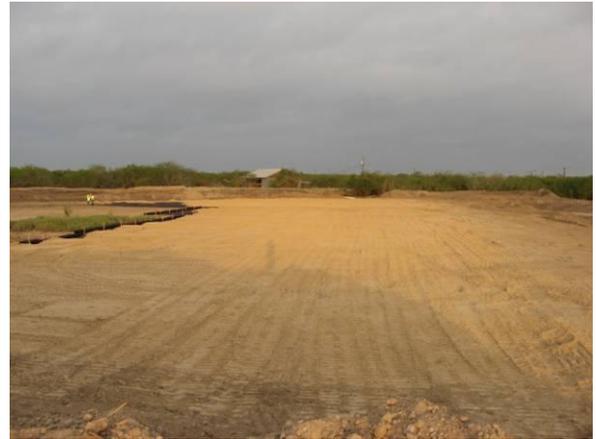
Photo 14 View of completed sand placement.

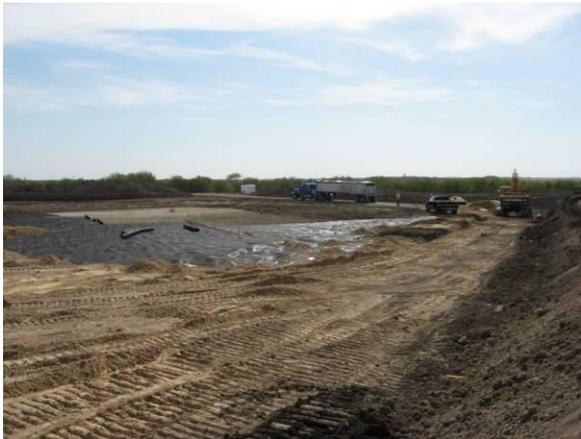
Photo 15 View of the east bank facing north.

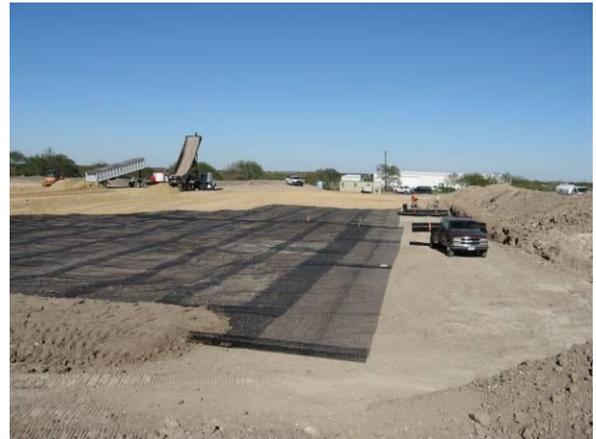
Photo 16 View from southern most corner of pit looking NE.

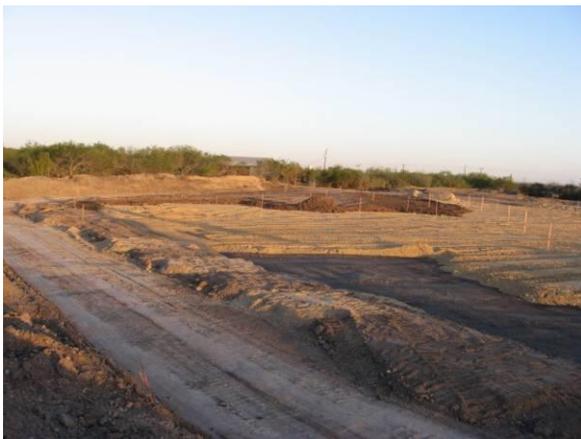
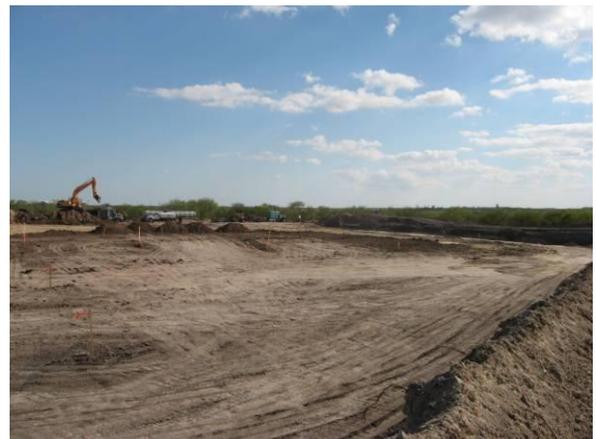
Photo 17 Impacted soil in the background being placed and compacted.

Photo 18 Impacted soil in background being placed and compacted.

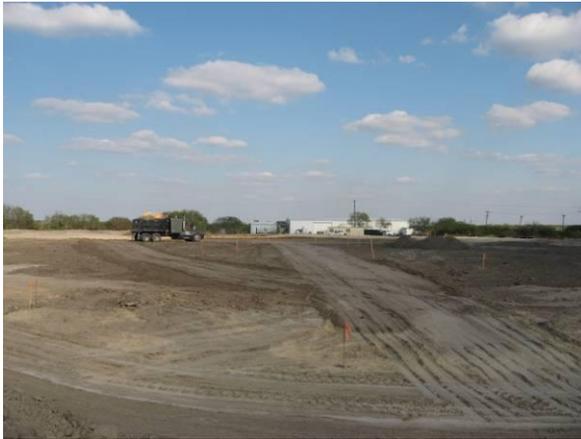
Photo 19 Clay lift placement, western most corner looking east.

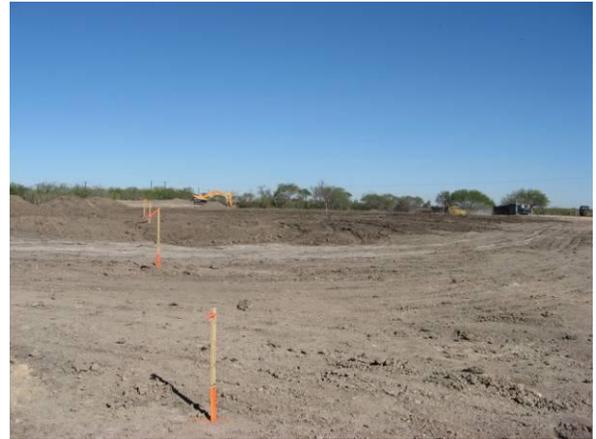
Photo 20 Grade stakes used for clay placement.

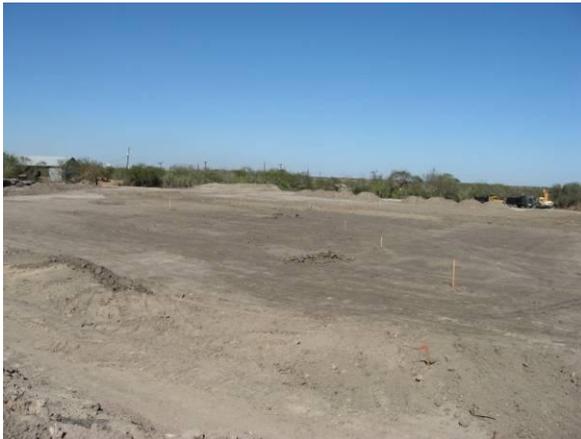
Photo 21 Clay layer looking north from southern most corner of pit.

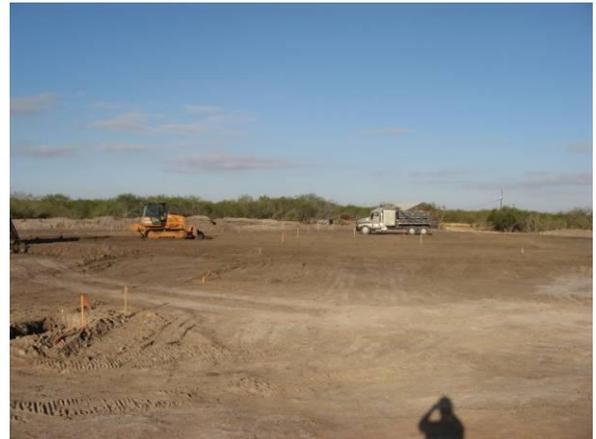
Photo 22 Clay cap material being graded and compacted.

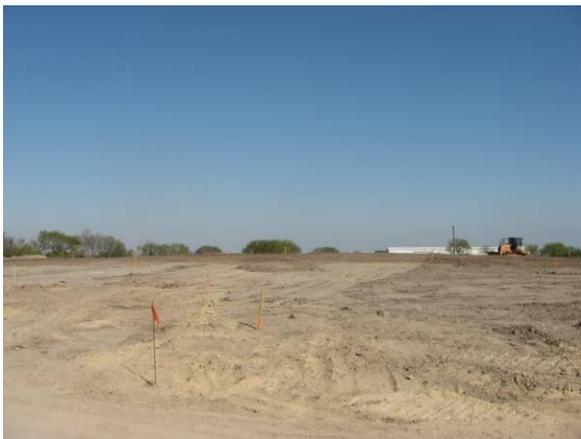
Photo 23 Placement and grading vegetative layer.

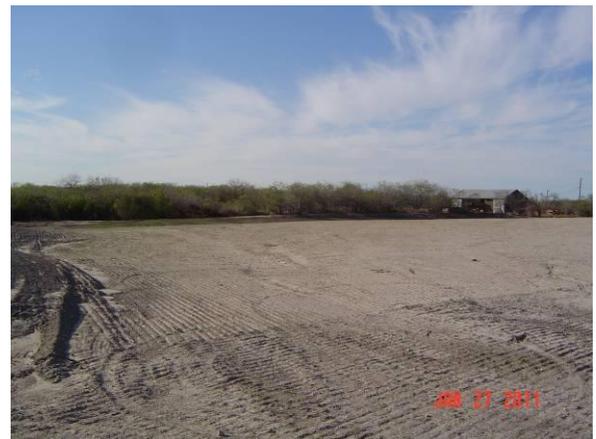
Photo 24 Completed cap two weeks after seeding, looking west.

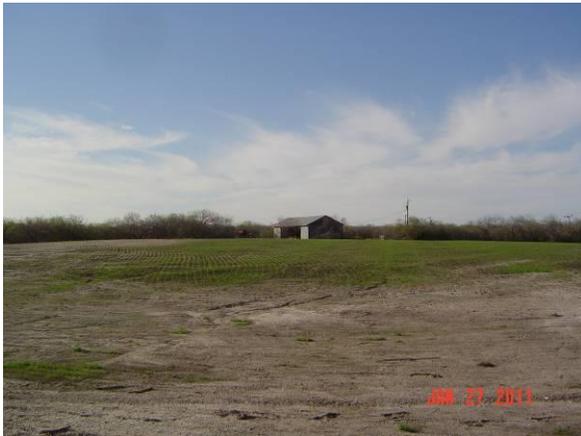
Photo 25 View of the completed cap two weeks after seeding.

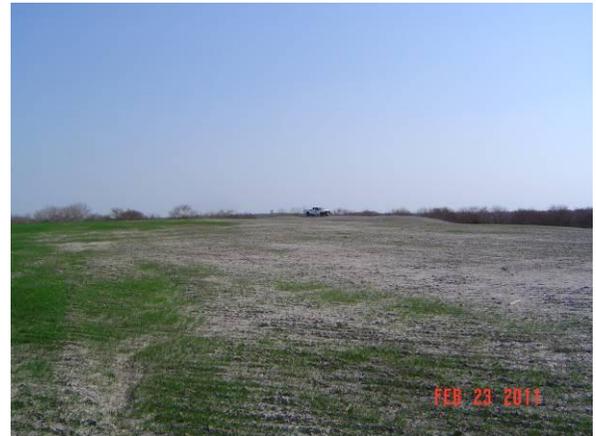
Photo 26 Bare spot where grass hasn't grown six weeks after seeding.

The scope of work as described in the Bid Documents was successfully completed by the Contractor in its entirety. As discussed earlier, drought conditions following the Contractor's initial seeding in January, 2011 affected the establishment of the grass cover and delayed the Final Inspection. The RRC and the Contractor reviewed options for reseeded the Cap, and in February 2012, the cap was re-seeded, watered by the Contractor, and vegetation established. A final inspection of the site took place in August 2012, and there were no deficiencies identified needing address by the Contractor.

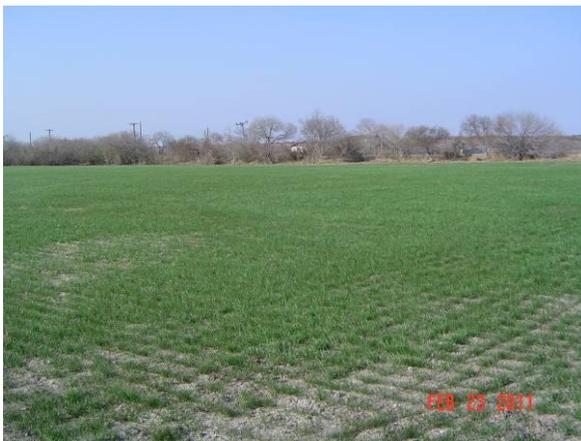
Photo 27 Grass growth on cap six weeks after seeding.

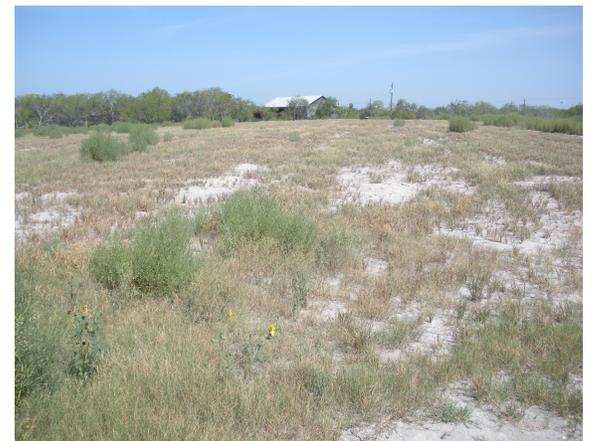
Photo 28 Grass growth on cap Aug. 2012
